November 3, 2015

Re: Annual Closed Landfill Inspection – Congress and Nearmont Landfills

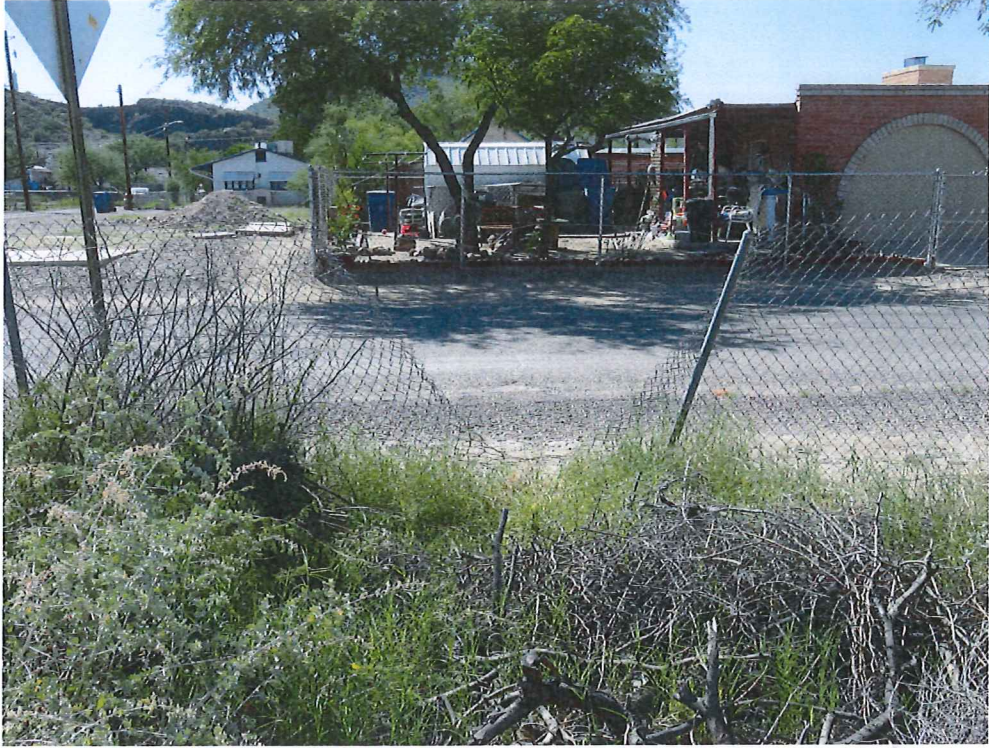
The majority of the perimeter of the landfills is unfenced. A fence along the northwest boundary of Nearmont Landfill is in disrepair (Photo 1).

Photo 1: Fencing on northwest boundary of Nearthmont LF

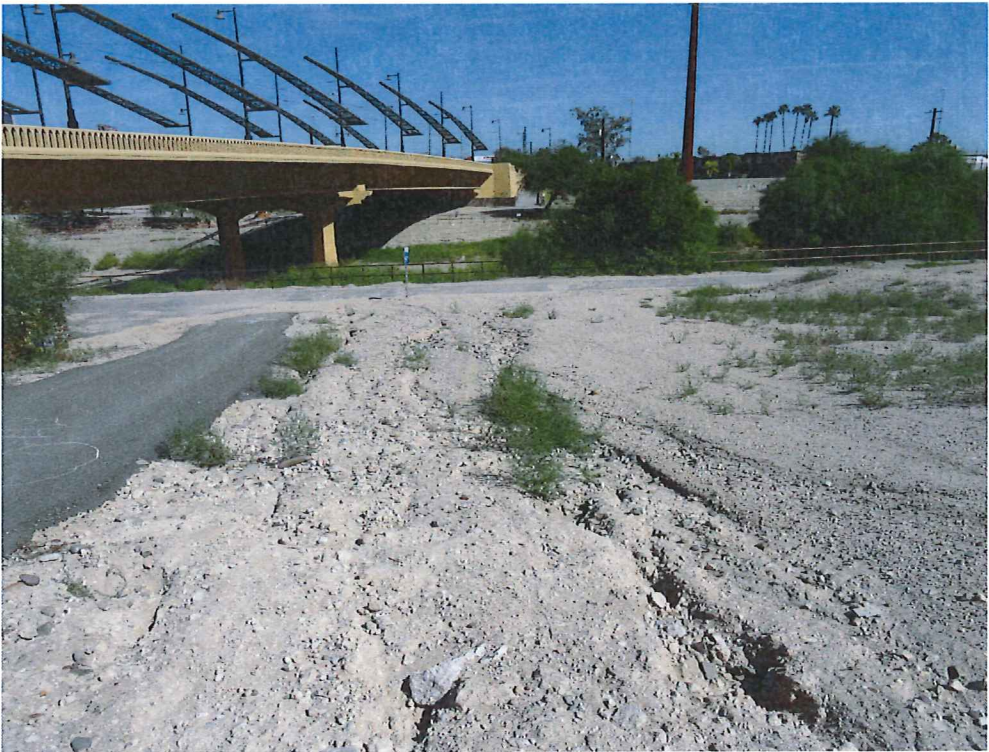
Rill erosion was observed at the east edge of Congress landfill adjacent to the Cushing Street Bridge over the Santa Cruz River (Photo 2).

Photo 2: Erosion rilling on east slope of Congress LF near the Cushing Street Bridge

- Monitor rill erosion at the east edge of Congress landfill adjacent to the Cushing Street Bridge for possible future repair.
- Monitor areas of standing water on Congress Landfill for possible future repair.
- Repaint groundwater monitoring well boxes to cover graffiti.
- Remove misc. trash and surface debris that has been dumped on site.

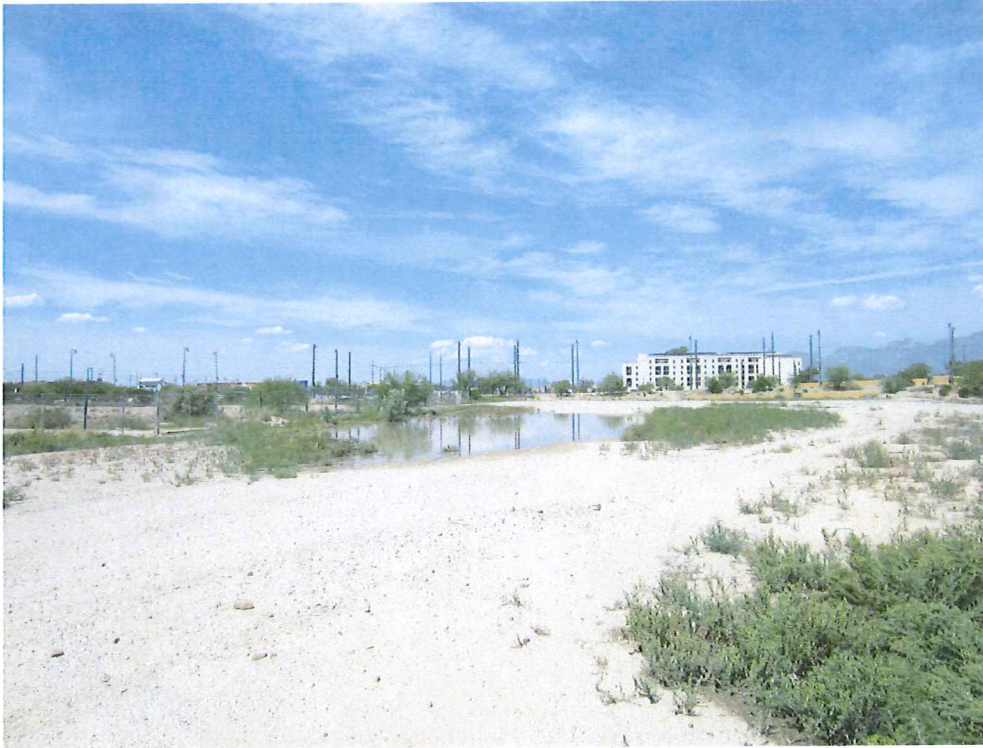
The landfill cap is generally in good condition but areas of stormwater ponding were observed on Congress Landfill (Photo 3).

Photo 3: Ponding water on Congress Landfill

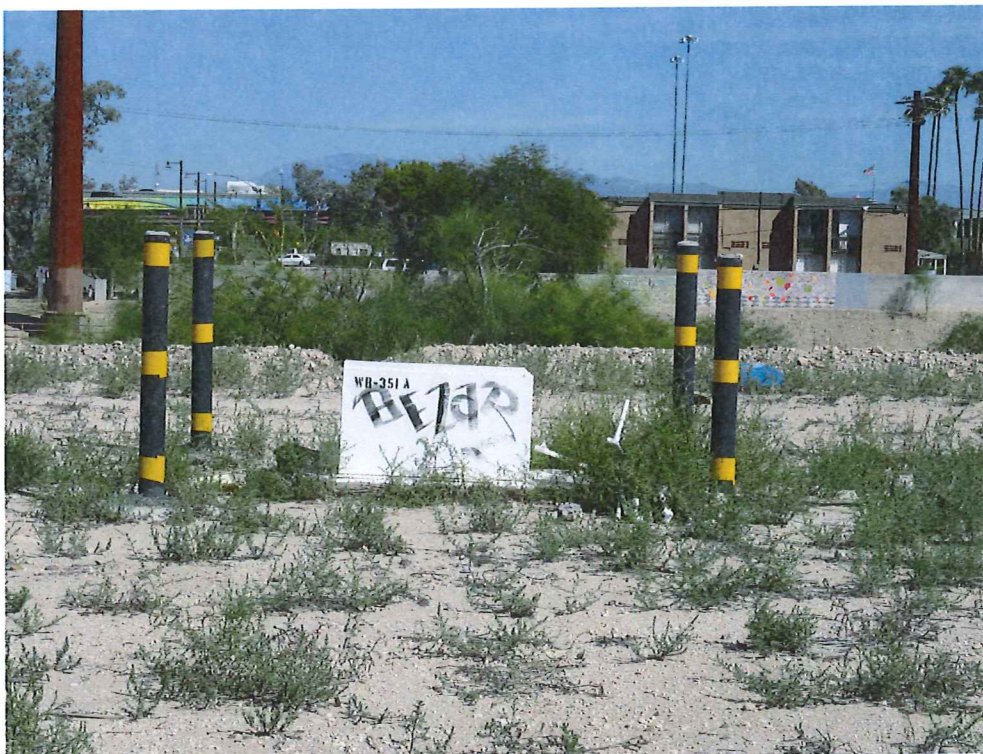
The groundwater wells at the property appear to be in good condition but have been tagged with graffiti (Photo 4).

Photo 4: Graffiti on groundwater monitoring well

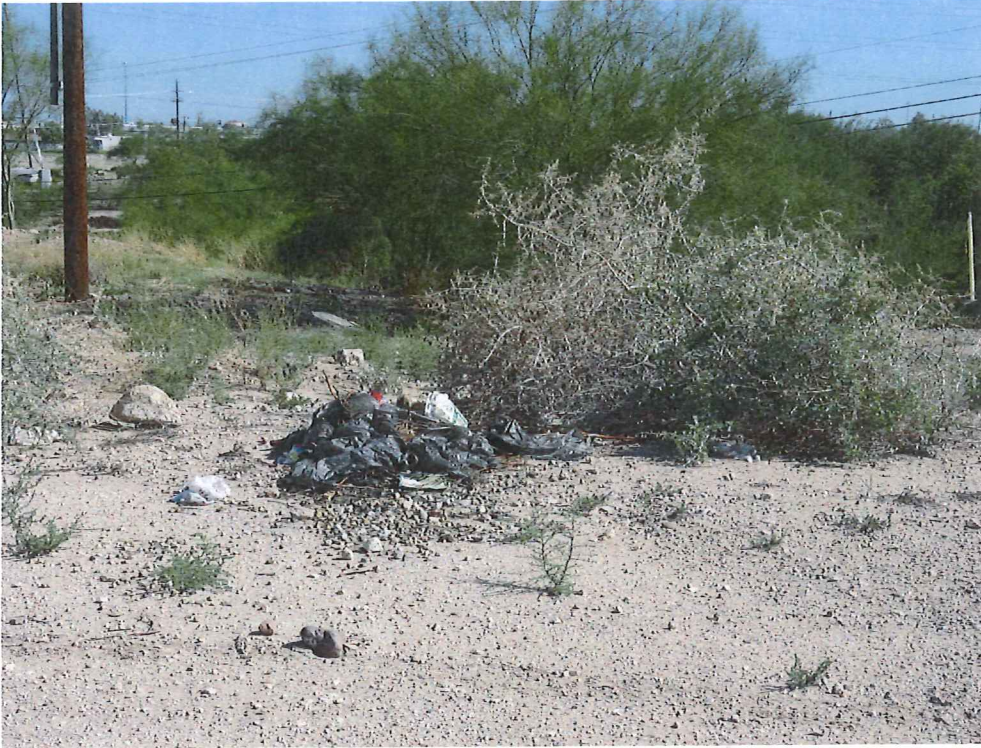
Miscellaneous surface debris and dead vegetation was observed in various location during the inspection. (Photos 5, 6, 7, 8).

Photo 5: Miscellaneous debris dumped on landfills

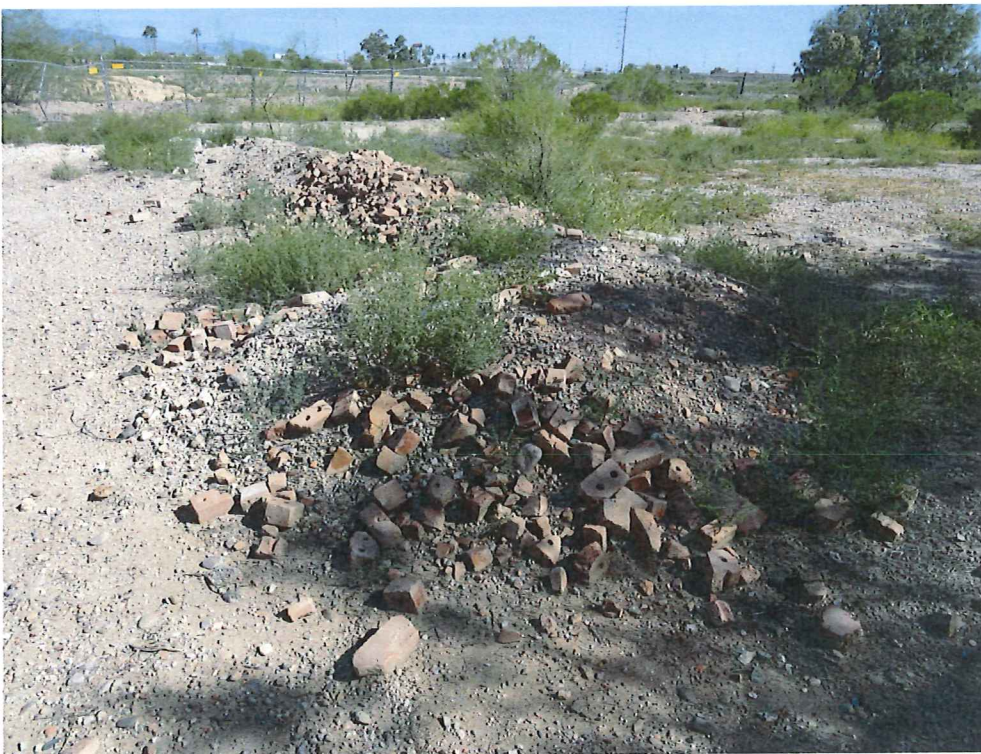
Photo 6: Surface debris on landfills

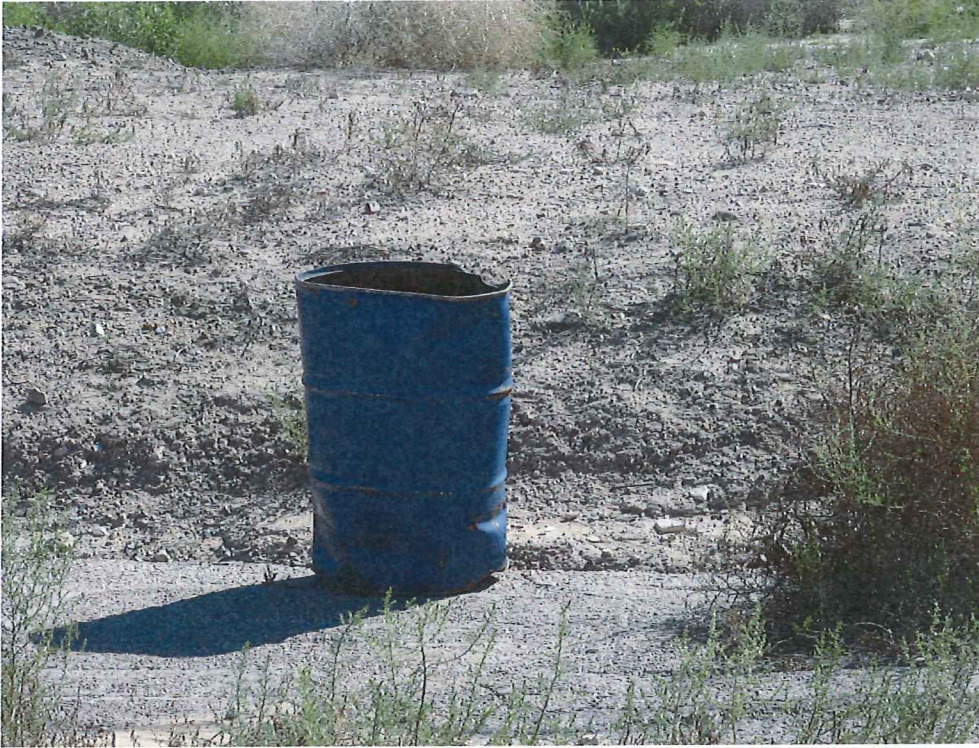
Photo 7: Debris/Trash dumped on landfills

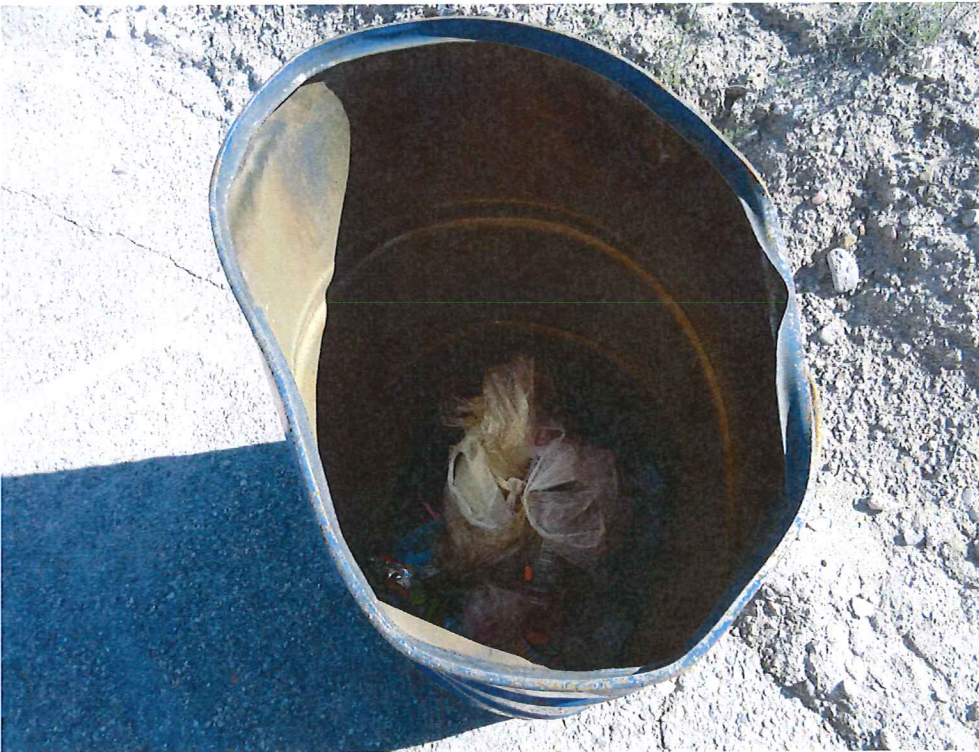
Photo 8: : Debris/Trash dumped on landfills
