Re: Annual Closed Landfill Inspection – A Mountain Landfill

**CITY OF TUCSON ENVIRONMENTAL SERVICES
ANNUAL CLOSED LANDFILL INSPECTION REPORT
A MOUNTAIN LANDFILL**

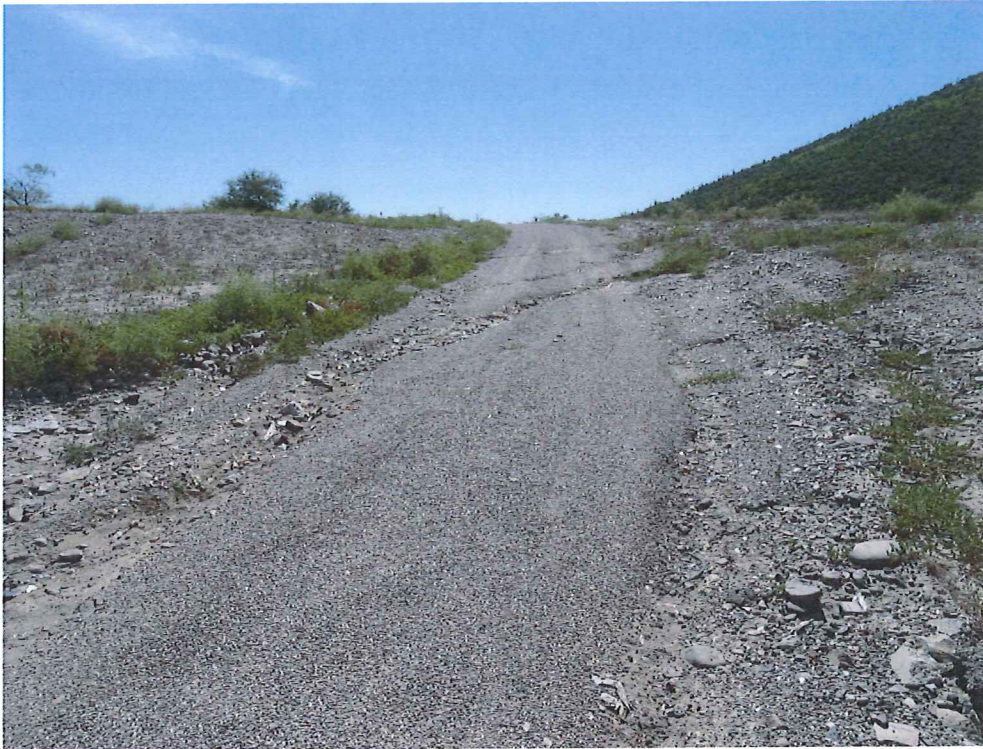
Exposed trash was observed in rills on the northern end of the central inspection road (Photos 1, 2).

Photo 1: Erosion rills on inspection road with exposed trash, view to the south

- The exposed trash and debris observed in erosion rills on the north slope of the landfill adjacent to the Mission Gardens complex and the central inspection road should be covered with clean fill.
- The erosion on the east slope of the landfill above the County multi-use path was noted as an action item in the 2014 report, with a minor redesign of the drainage being the preferred remedy. This had not occurred at the time of this inspection.

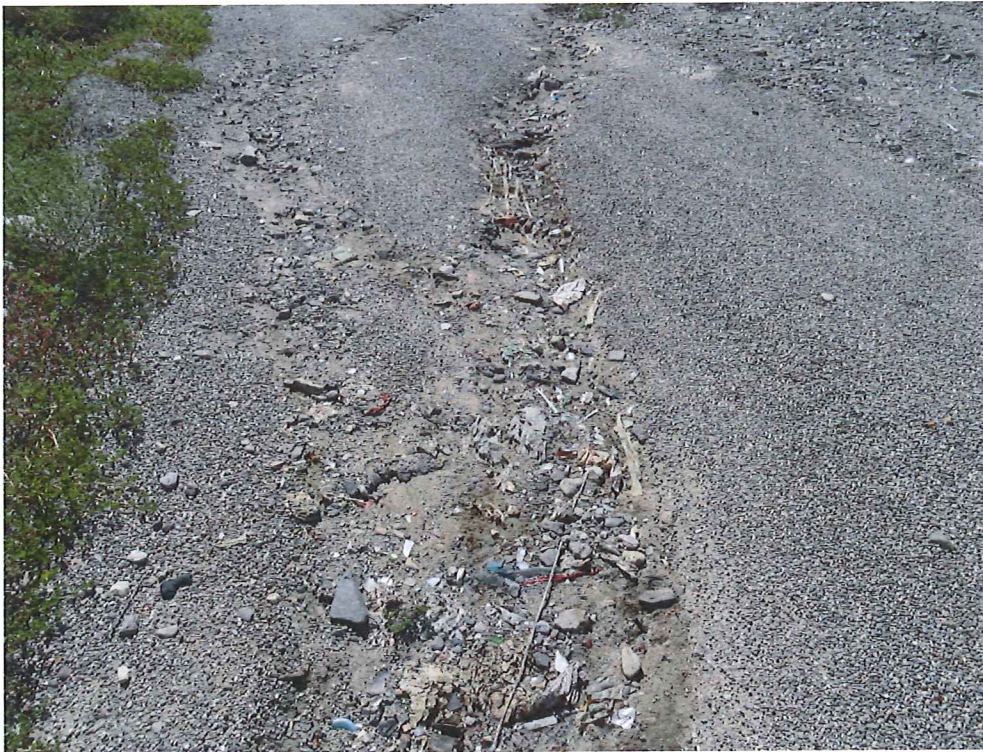
Photo 2: Exposed trash in rills in inspection road

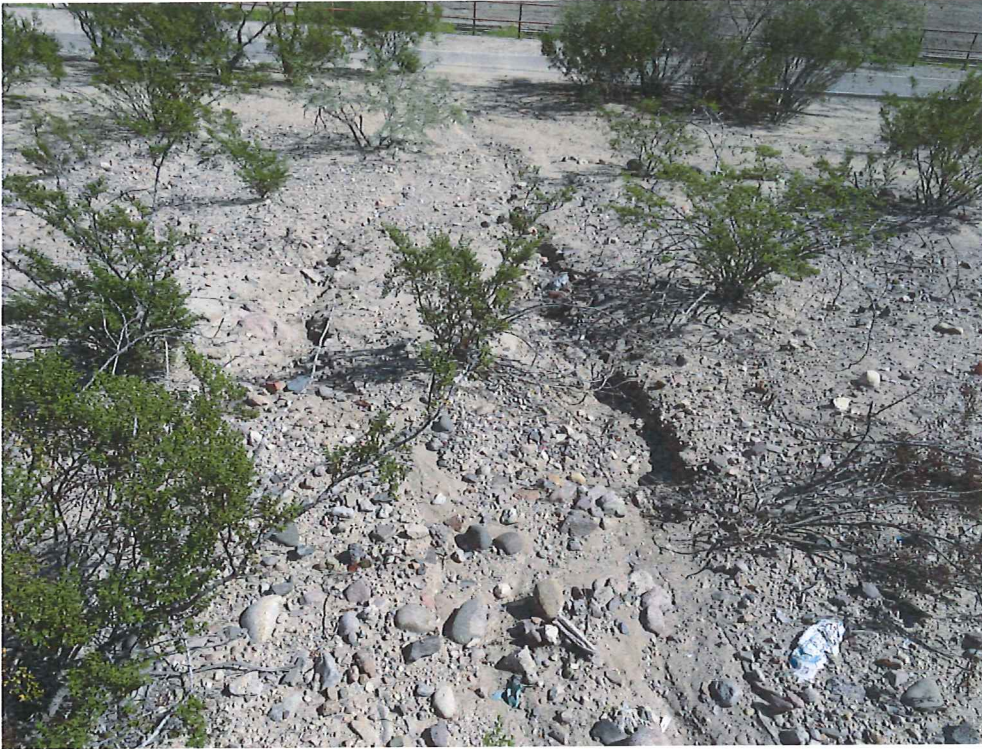
Erosion rills with exposed trash were observed on the east slope of the landfill above the Pima County multi-use path along the Santa Cruz River (Photos 3, 4). This item was also noted in the 2014 annual report as an item for drainage redesign and repair.

Photo 3: Rill erosion on east slope of landfill above County multi-use path

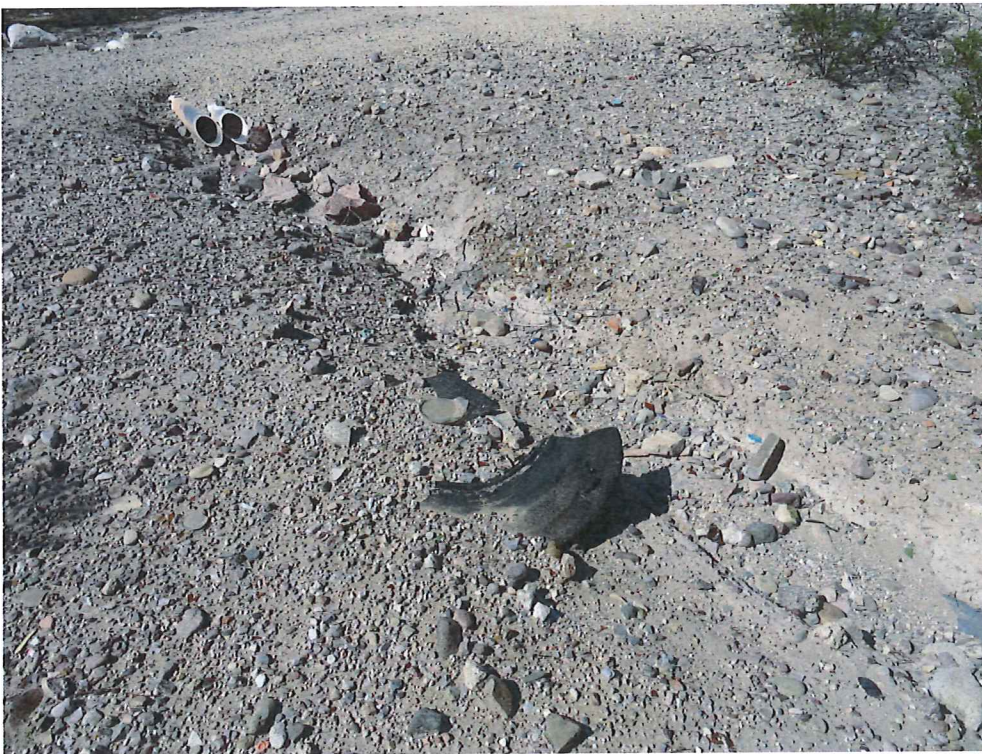
Photo 4: Exposed trash in rill on east slope above County multi-use path

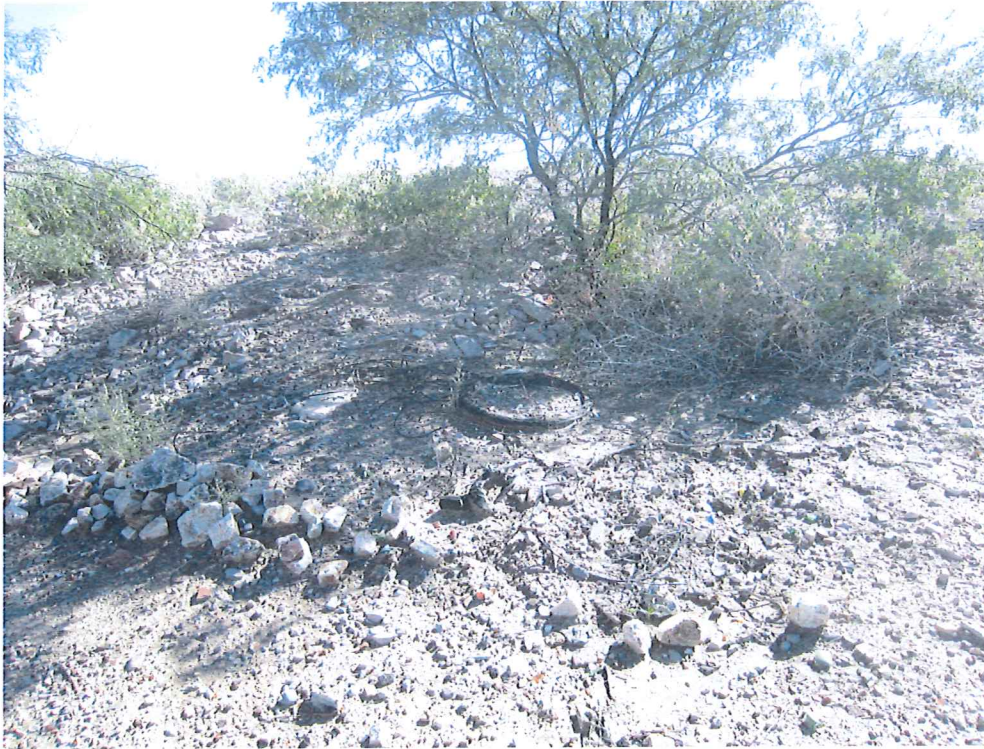
The earthen cap is thin in some areas of the landfill and minor erosion can expose trash in these areas. Exposed trash and debris due to erosion was observed on the north slope of the landfill near the Mission Gardens complex (Photo 5, 6).

Photo 5: Exposed trash on slope adjacent to Mission Gardens

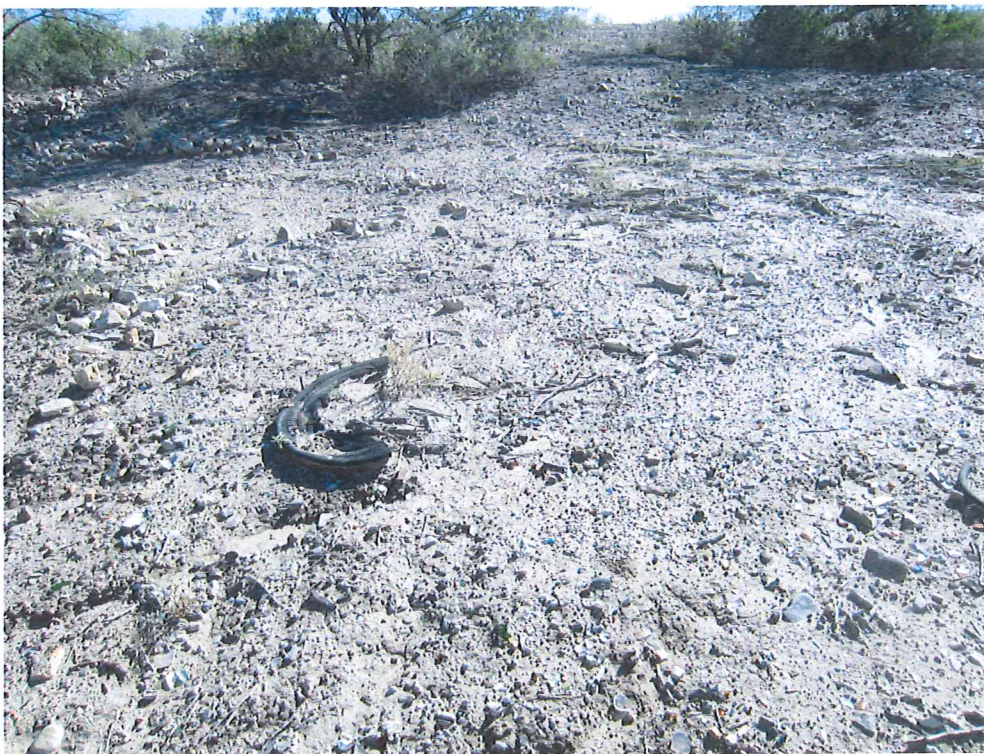
Photo 6: Exposed trash on slope adjacent to Mission Gardens
