November 3, 2015

Re: Annual Closed Landfill Inspection – Cottonwood Landfill

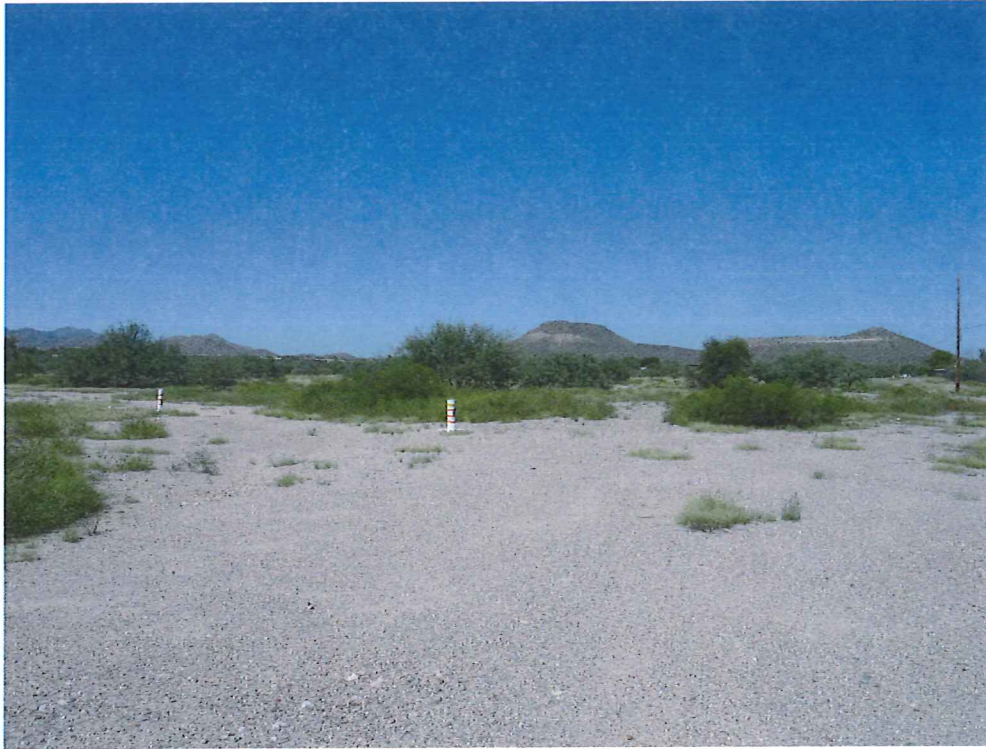
The landfill cap is in good condition in most areas (Photo 1), except for an area near the northwest corner of the property where subsidence and cap cracking was observed (Photo 3).

Photo 1: View of landfill cap with gas monitoring wells – looking north

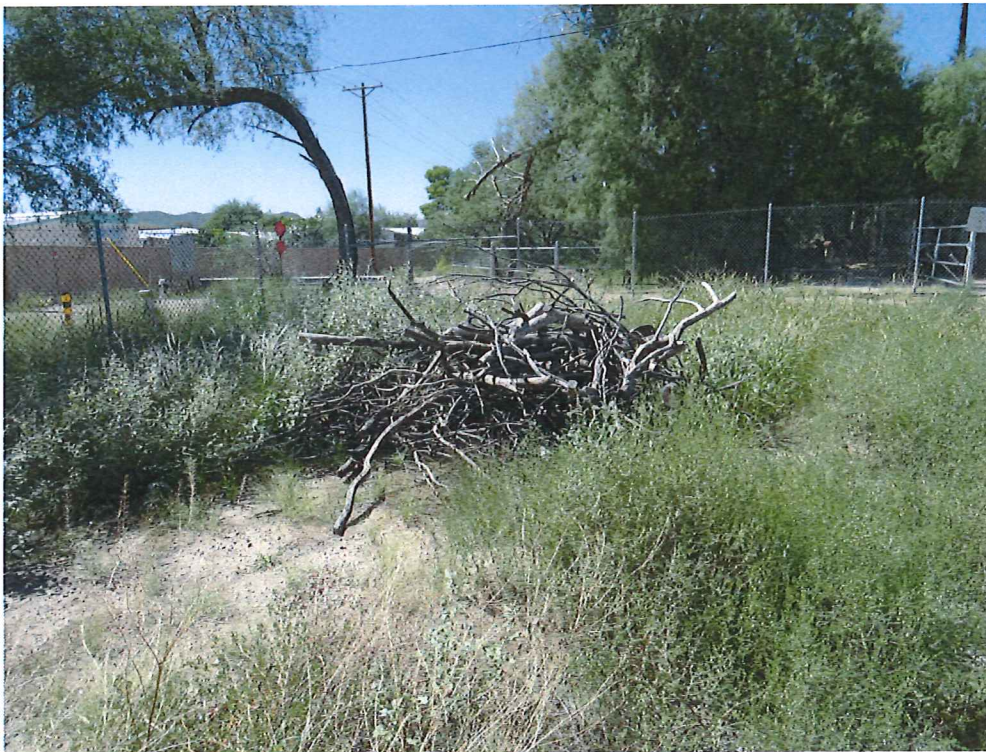
Downed vegetation and debris was observed on portions of the property. (Photos 2, 4, 5).

Photo 2: Dead vegetation near southwest corner of landfill

- A general cleanup of downed vegetation and surface debris as recommended in the 2014 report still should be performed.

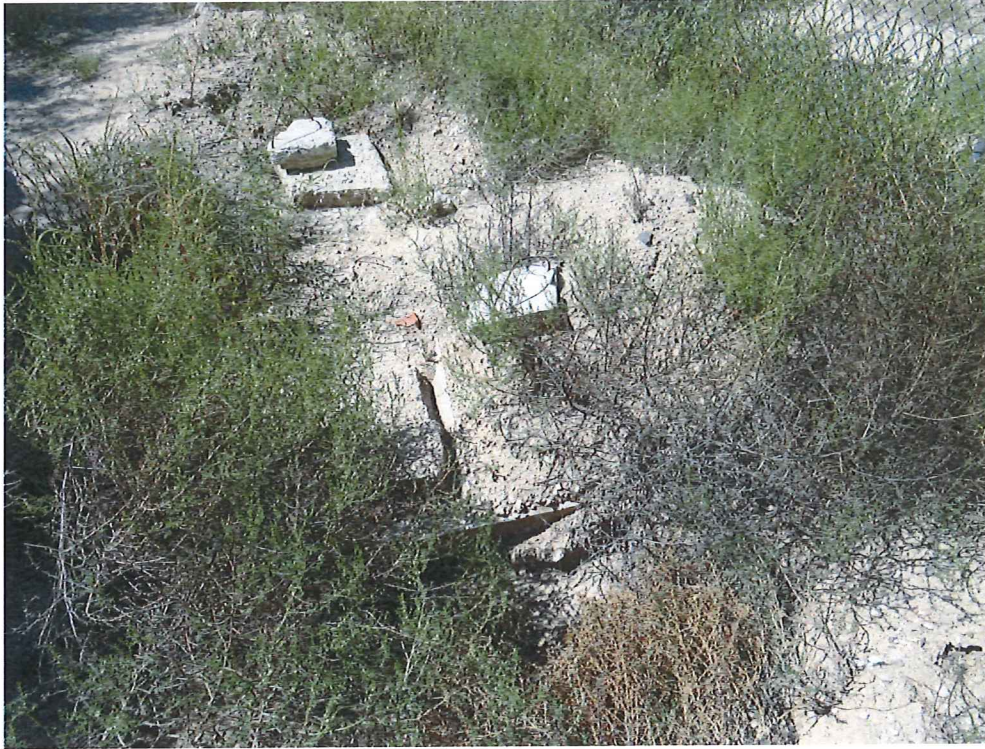
Photo 3: Localized surface cracking and subsidence near northwest corner

- The areas of localized surface cracking and subsidence near the northwest corner of the property should be repaired with imported soil. This item was also a recommendation in the previous annual inspection report (dated 11/14/14).

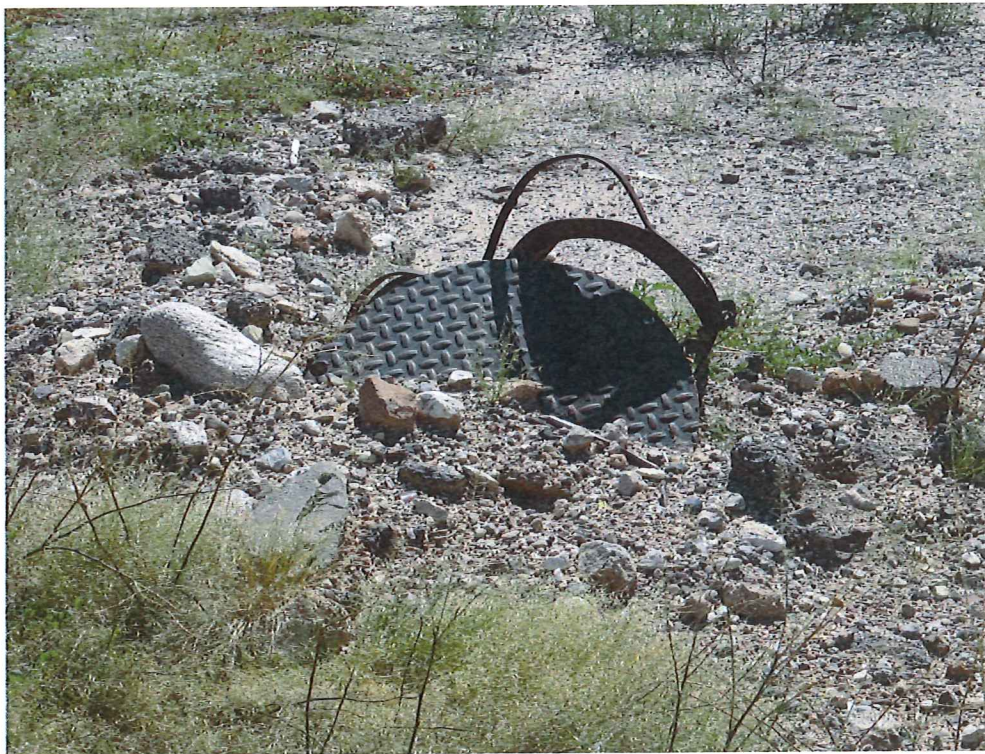
Photo 4: Miscellaneous debris on landfill surface

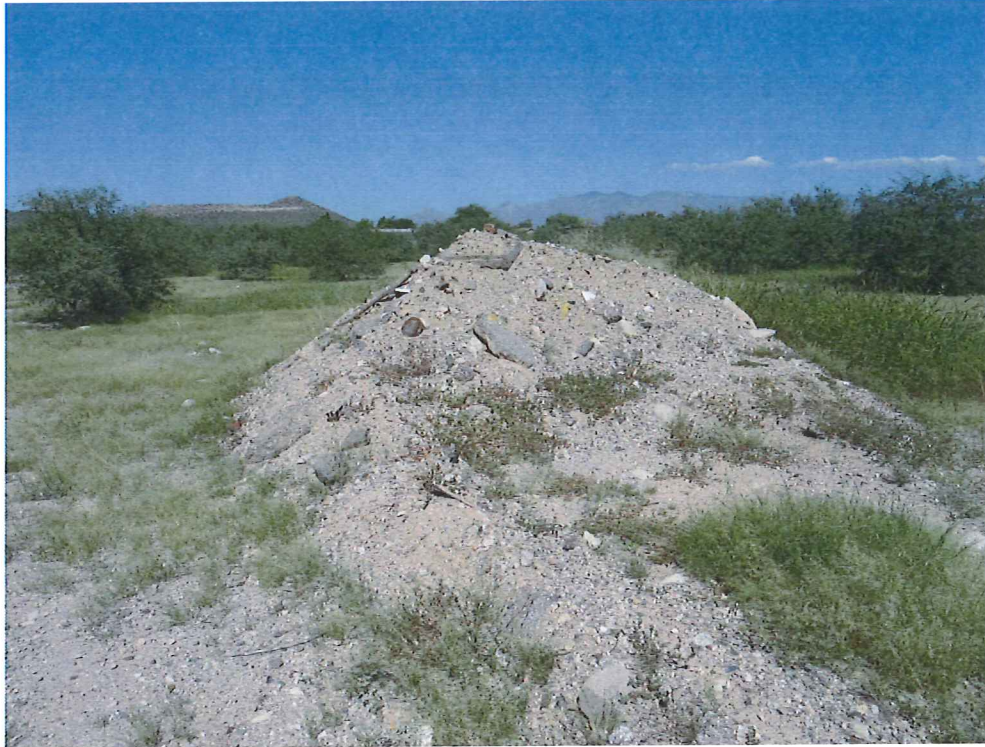
Photo 5: Miscellaneous soil and debris dumped on central cap – looking north
