November 3, 2015

Re: Annual Closed Landfill Inspection – Prudence Landfill

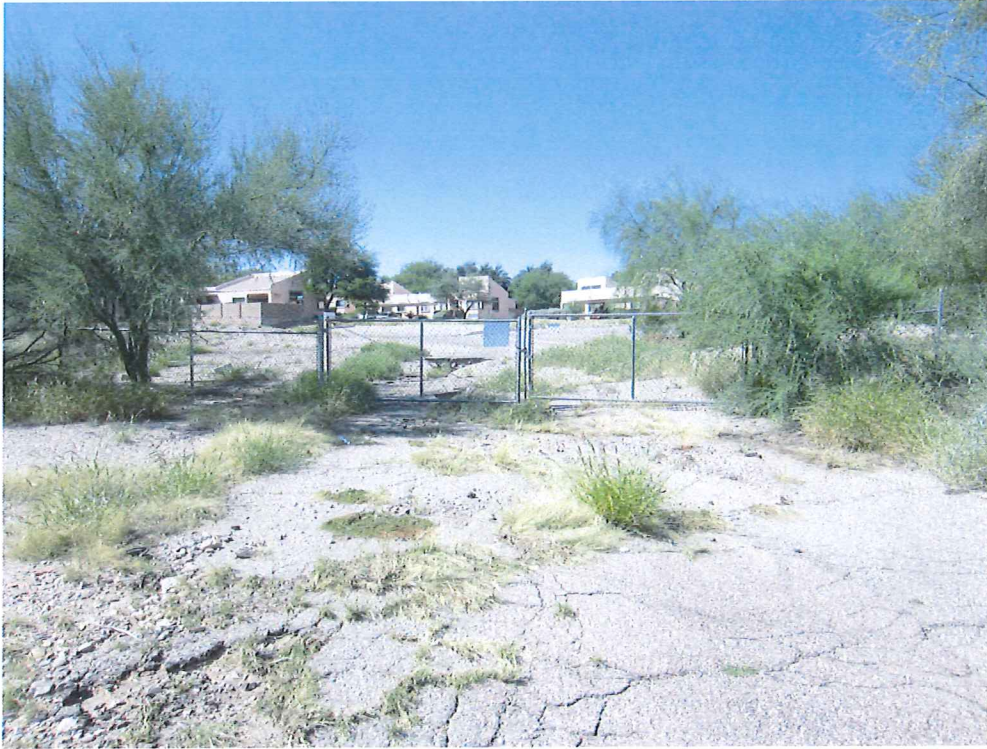
The engineered drainage from the adjacent apartment complex towards the Pantano Wash is in very poor condition. A repair project initially planned by the City has not been completed.

Photo 1: Damaged asphalt drainage

The asphalt drainage north of the remediation compound is badly eroded. The erosion is head-cutting into the adjacent townhome property. This drainage should be repaired. While equipment is on site to make these repairs, the less critical rutting on the access roads can be easily repaired also.

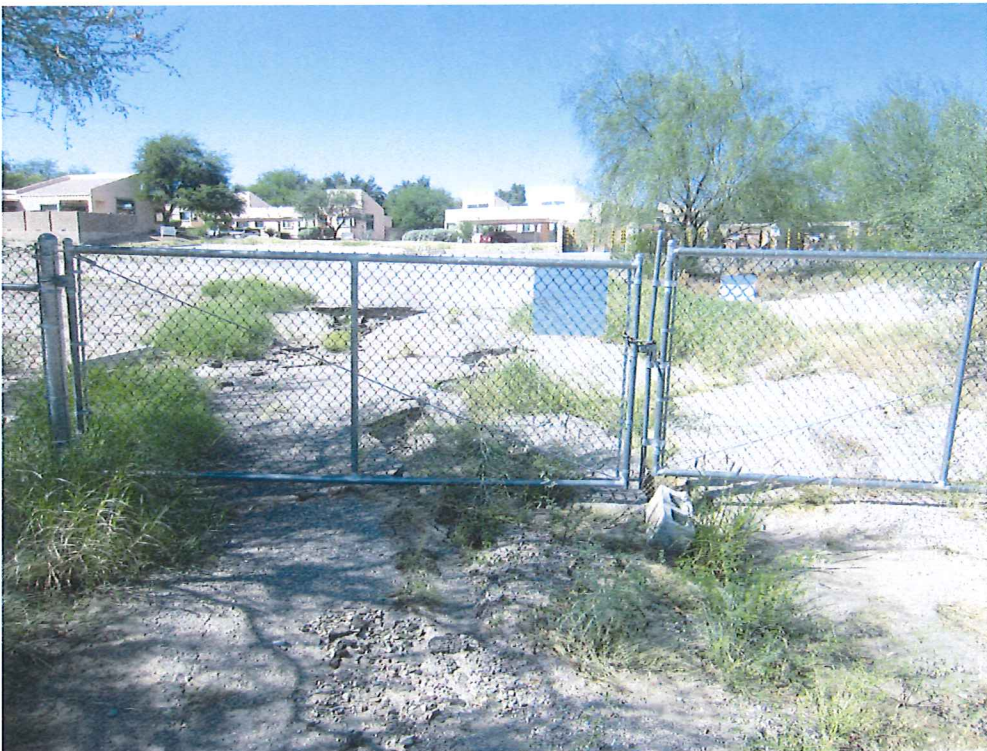
Photo 2: Western portion of damaged asphalt drainage

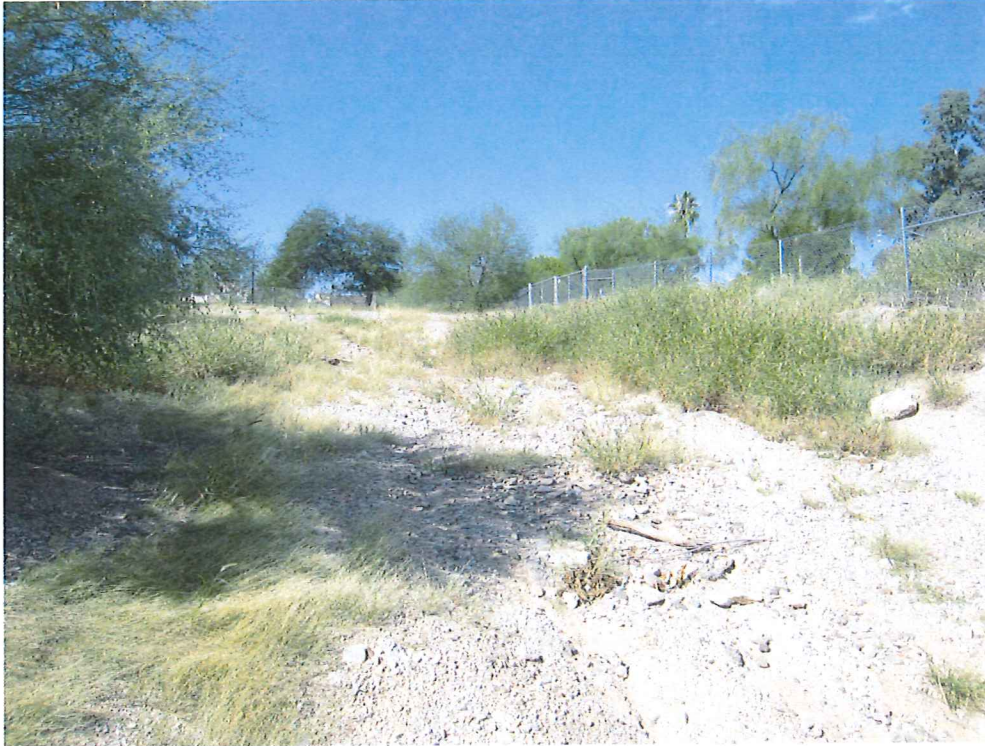
Photo 3: Rilling on earthen drainage, worst rilling obscured by weeds

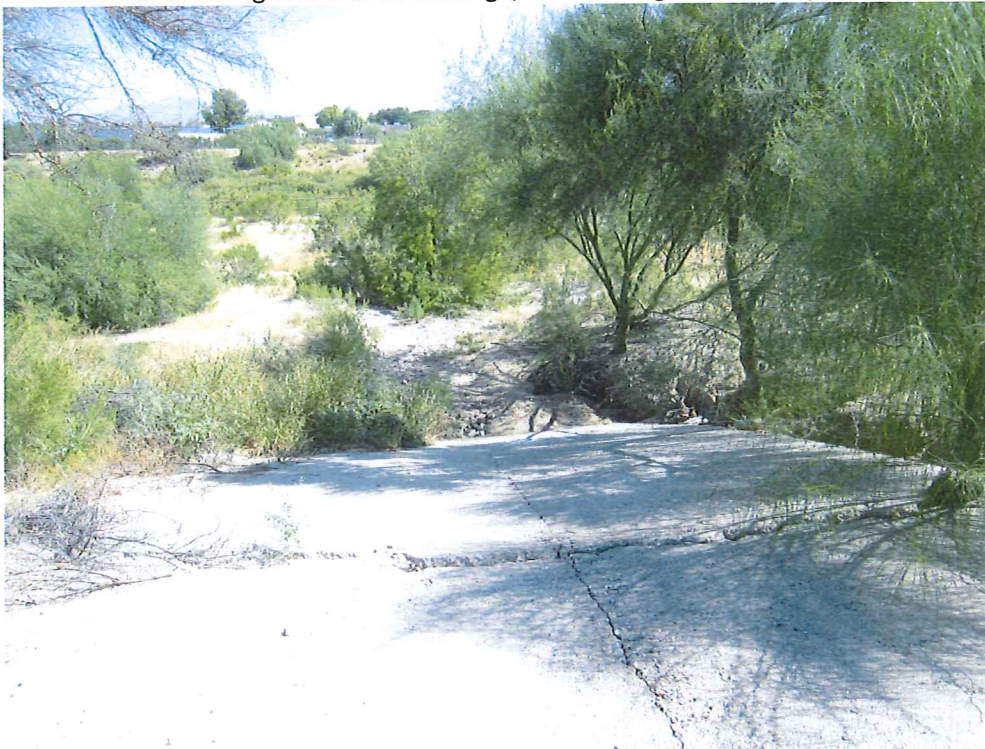
Photo 4: Lower portion of main drainage
