Re: Annual Closed Landfill Inspection – Ryan Airfield landfill

**CITY OF TUCSON ENVIRONMENTAL SERVICES
ANNUAL CLOSED LANDFILL INSPECTION REPORT
RYAN AIRFIELD LANDFILL**

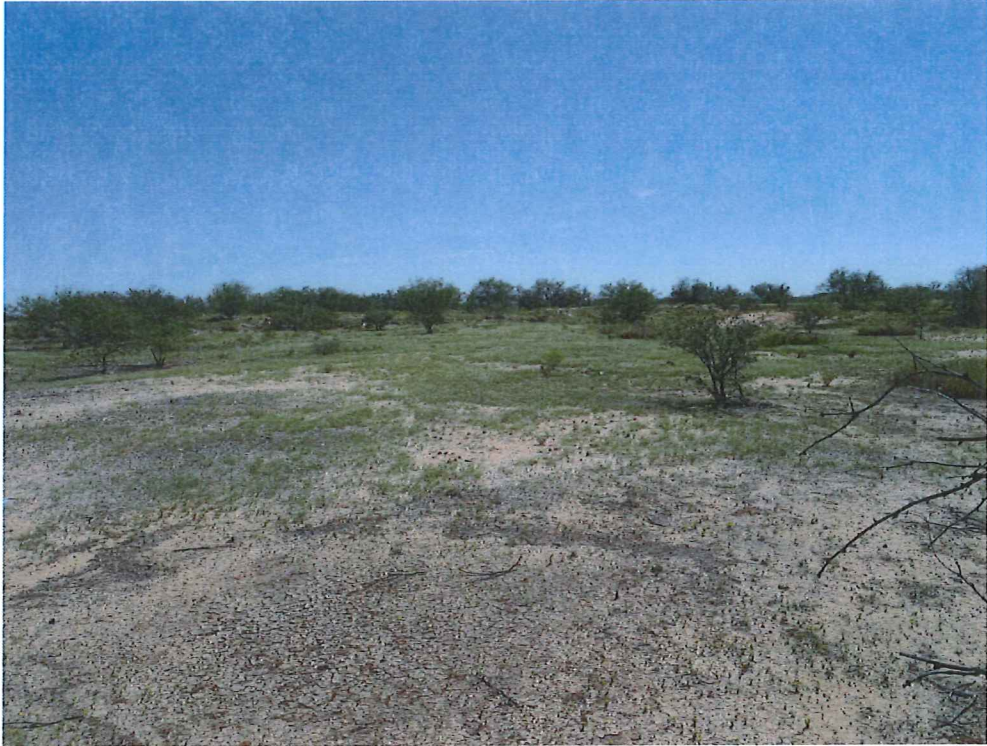
The earthen cap is in good condition.

Photo 1: Ryan Airfield Landfill earthen cap, view to the SW

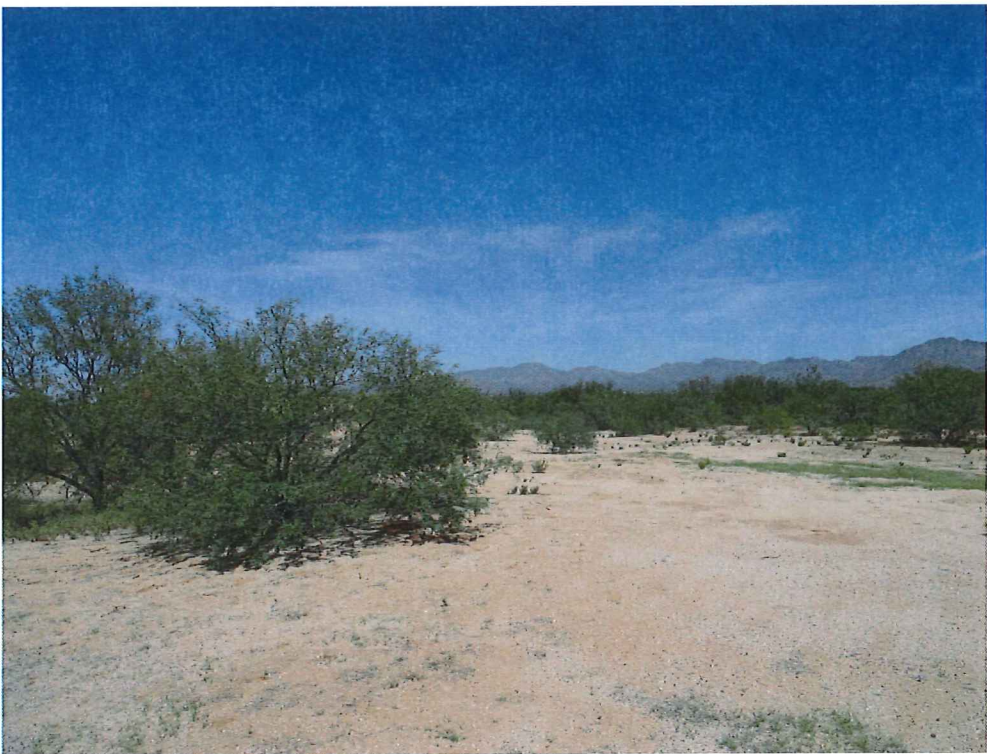
Photo 2: Ryan Airfield Landfill earthen cap, view to the NE
