November 3, 2015

Re: Annual Closed Landfill Inspection – Ryland Landfill

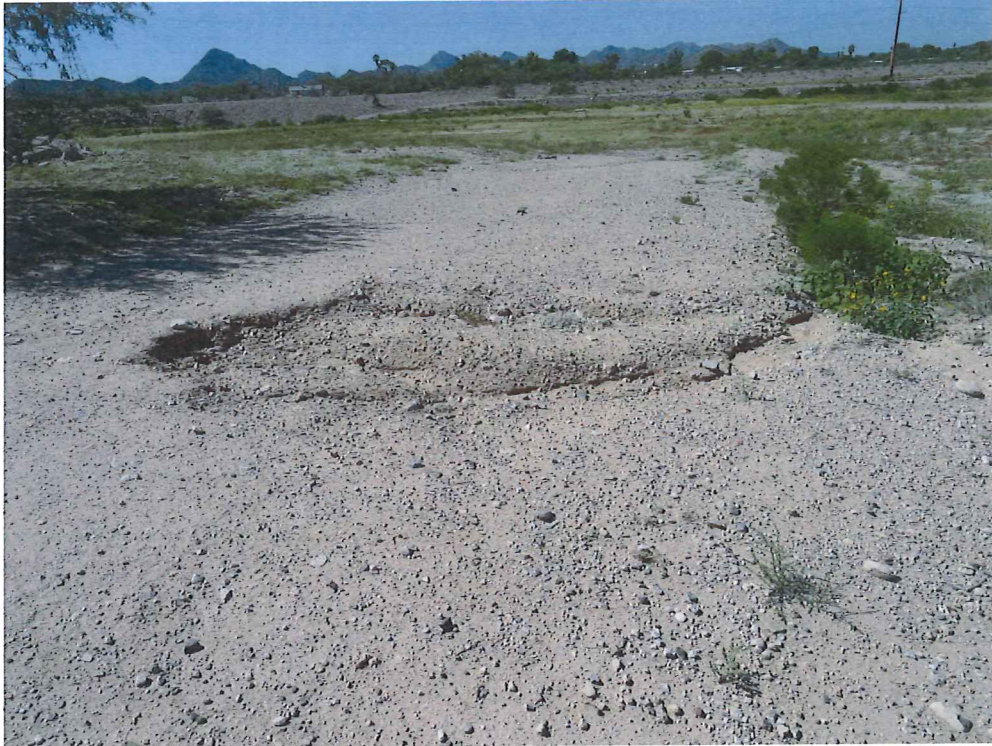
An erosion rill on the north landfill side slope was observed to extend into the north perimeter inspection road (Photo 1). Exposed trash was observed in the erosion rill (Photo 2). The remainder of the existing inspection roads on the property are generally in good condition.

Photo 1: View of erosion & head cutting on north inspection road

- Erosion on the north slope of the landfill should be repaired. Trash is exposed in the eroded slope and the erosion extends into the north perimeter inspection road.
- Extensive erosion at the south (upstream) end of the west slope of the landfill should be repaired. The existing erosion control wattles have been undermined.
- Graffiti on groundwater monitoring well boxes and bollards was noted as a recommended repair item in the 2014 annual report. It appears this repair was not performed.
- Surface debris on the landfill cap should be removed when equipment is on site to repair eroded areas discussed above.

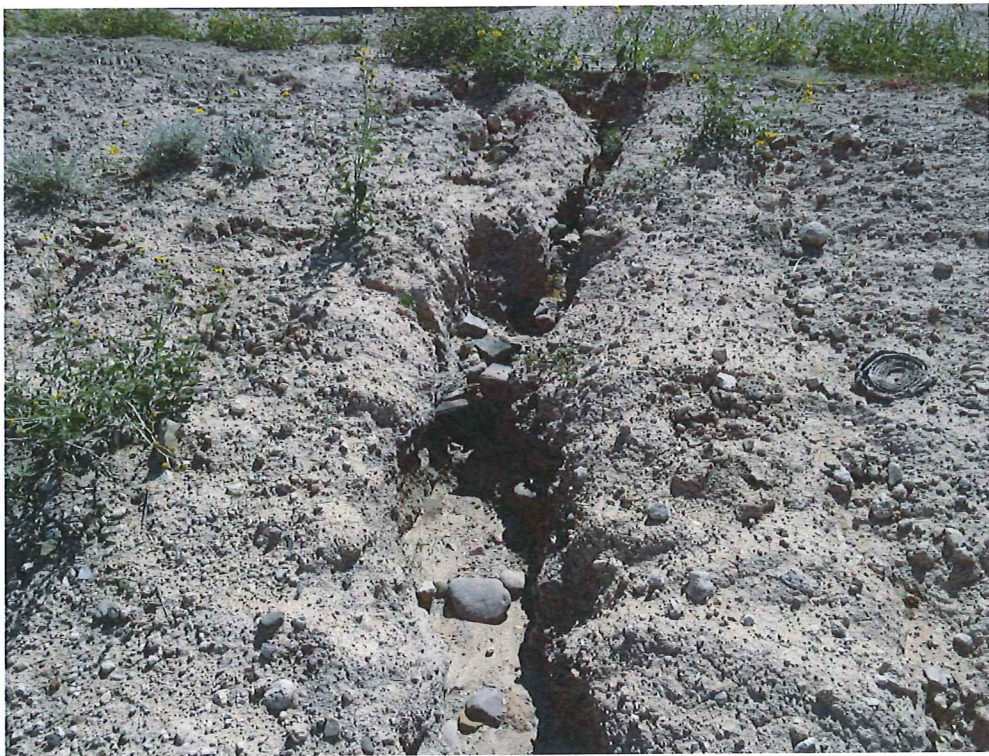
The landfill cap is generally in good condition in most areas, except for some areas near the northwest corner of the property along boundary drainage where erosion has exposed trash (Photos 2, 6).

Photo 2: Exposed trash in rill on north landfill slope

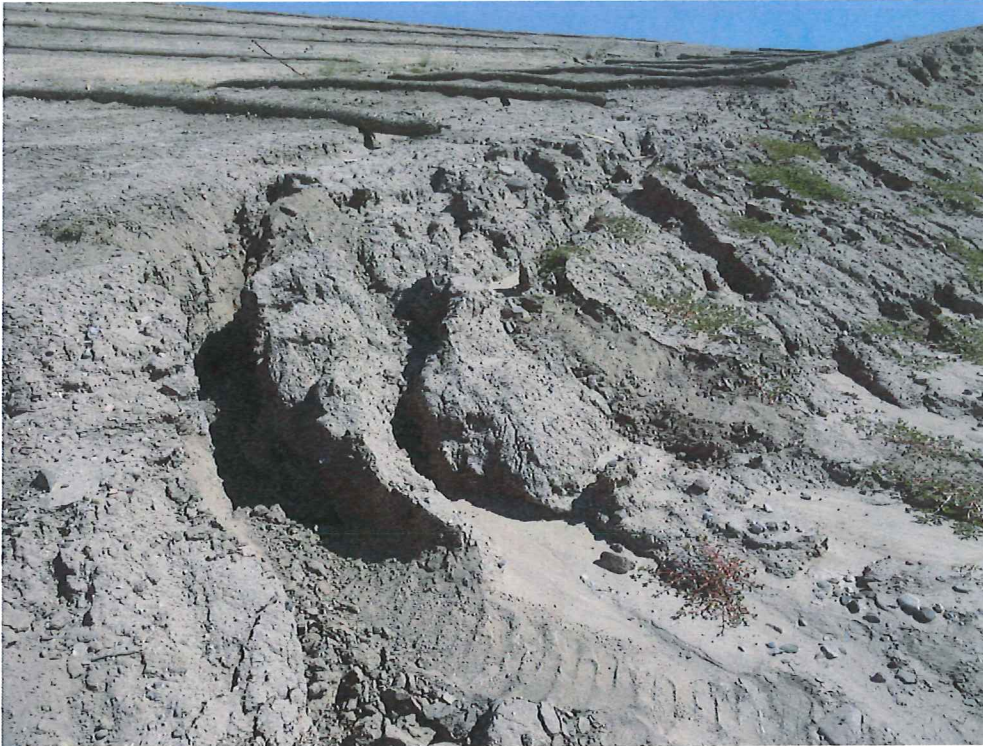
Significant erosion was observed at the upstream (south) end of the west slope of the landfill adjacent to the Santa Cruz River. Erosion control wattles installed in this area have been undermined by rill erosion (Photos 3 and 4).

Photo 3: Erosion at upstream (south) end of landfill west slope (at river)

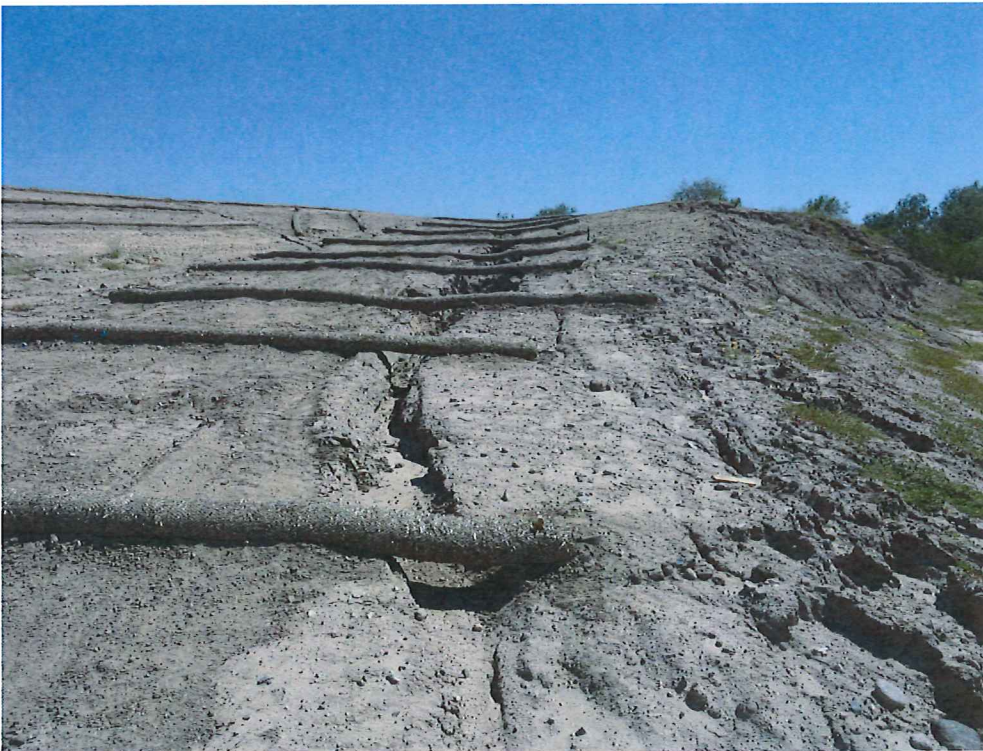
Photo 4: Erosion at upstream (south) end of landfill west slope (at river)

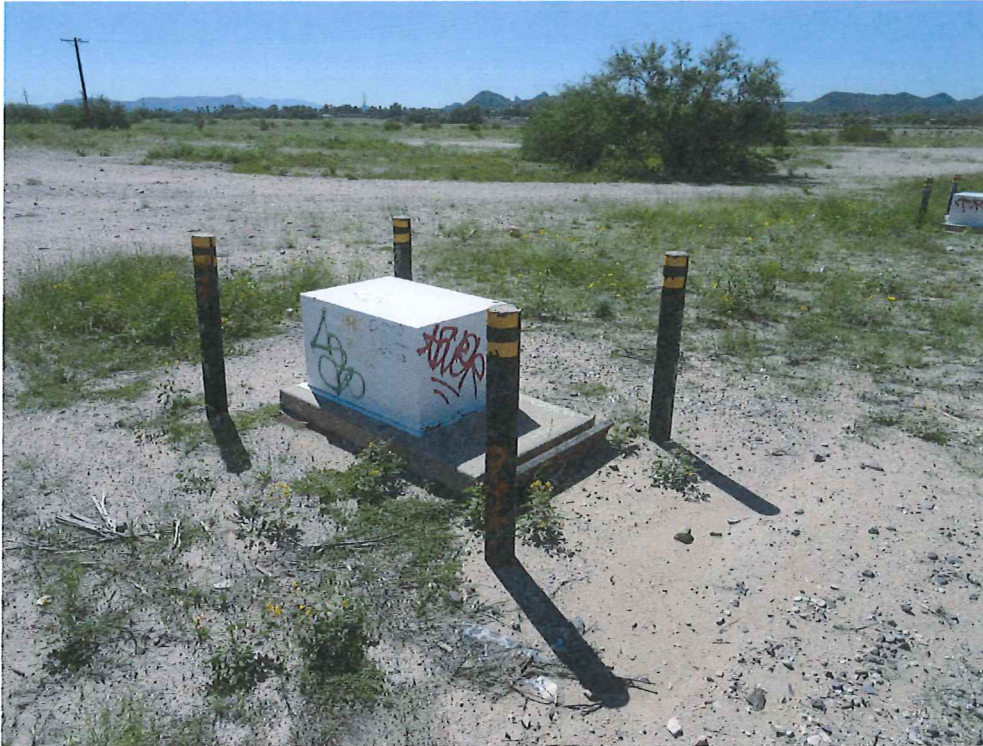
The groundwater wells at the property appear to be in good condition but have been tagged with graffiti (Photo 5).

Photo 5: Graffiti on groundwater monitoring well

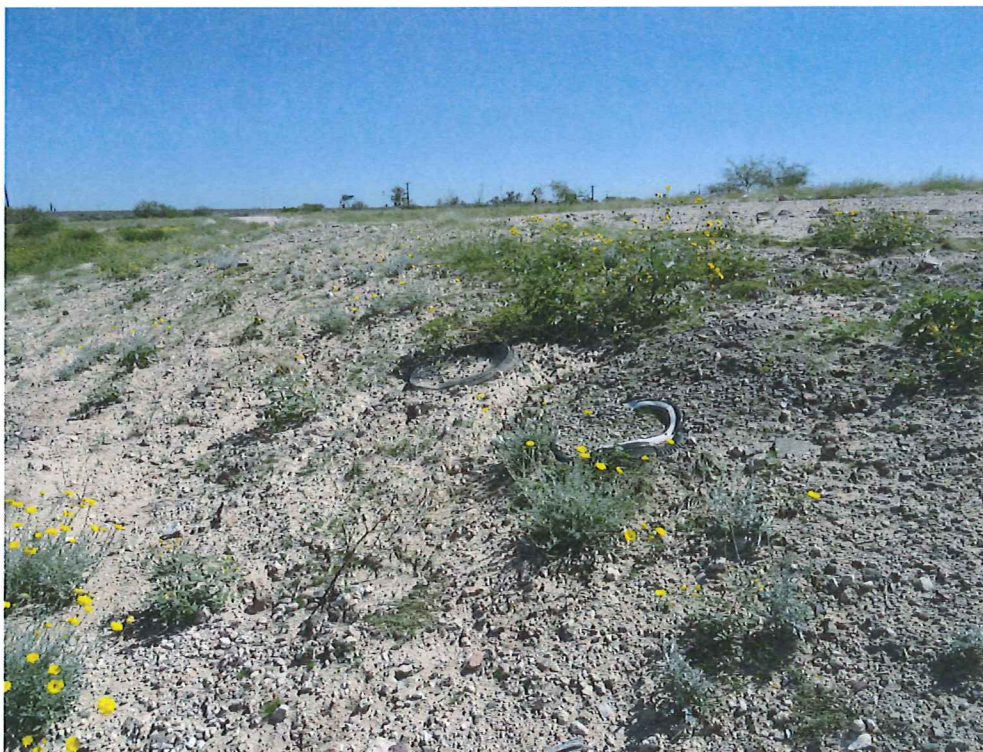
Photo 6: Miscellaneous debris outcropping on landfill slope

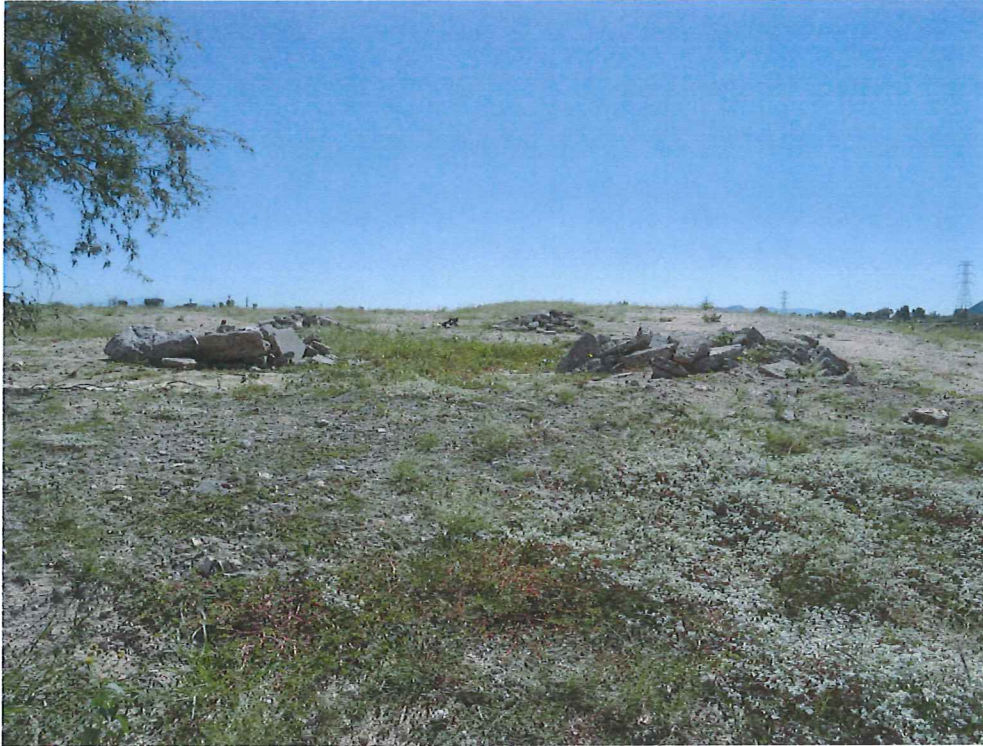
Miscellaneous debris in various location and a possible abandoned homeless camp were observed during the inspection. (Photos 7, 8, 9).

Photo 7: Concrete debris on landfill cap

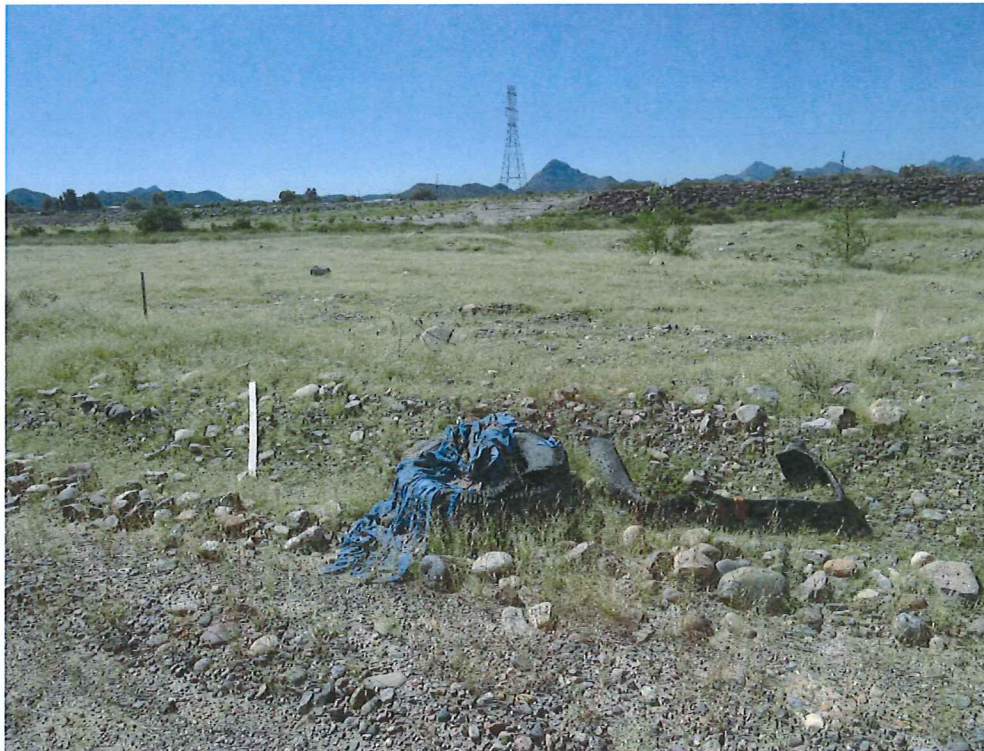
Photo 8: Miscellaneous debris on landfill cap

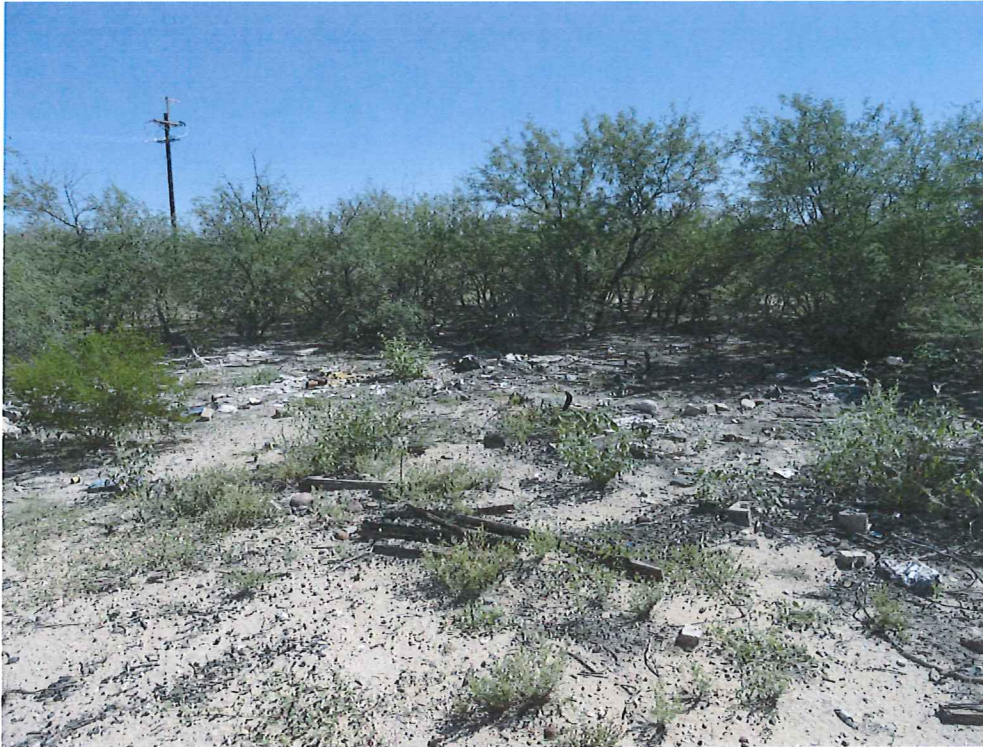
Photo 9: Miscellaneous debris on landfill cap (old homeless camp?)
