**TUMAMOC LANDFILL
TUCSON, ARIZONA**

**2017 ANNUAL MONITORING REPORT
GROUNDWATER AND METHANE GAS MONITORING RESULTS**

TUMAMOC LANDFILL INSPECTION REPORT
ANNUAL 2017
TUCSON, ARIZONA

FEBRUARY 9, 2018

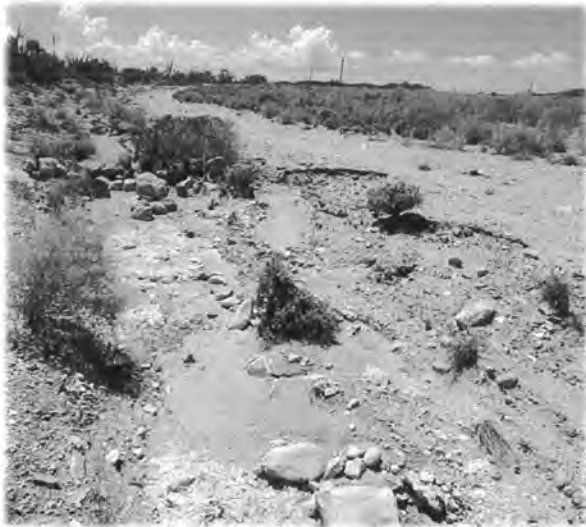
PHOTOGRAPH NO. 1

Erosion rills developing on eastside of east perimeter inspection road west of WR-449A. Viewed from the north.

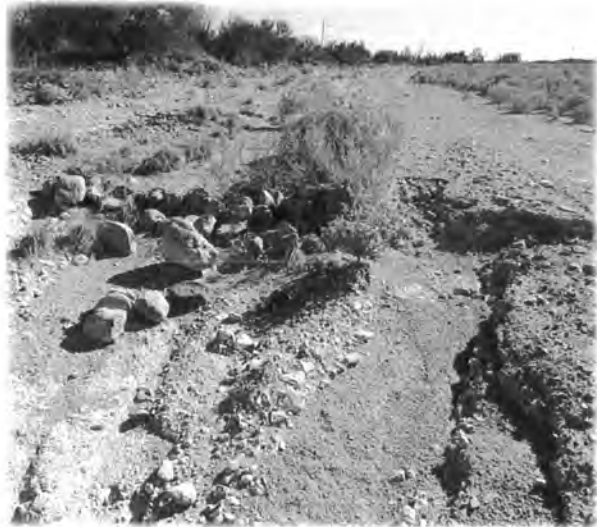
PHOTOGRAPH NO. 2

Erosion rills developing on eastside of east perimeter inspection road west of WR-449A. Viewed from the north.

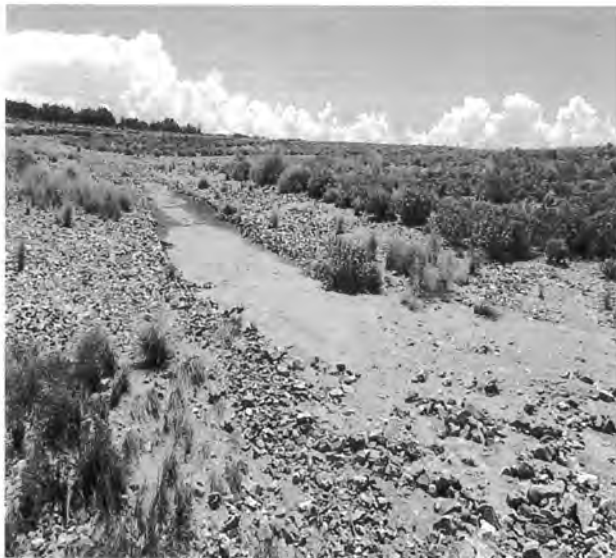
PHOTOGRAPH NO. 3

Exposed fabric with displaced rip-rap. Viewed from the west.

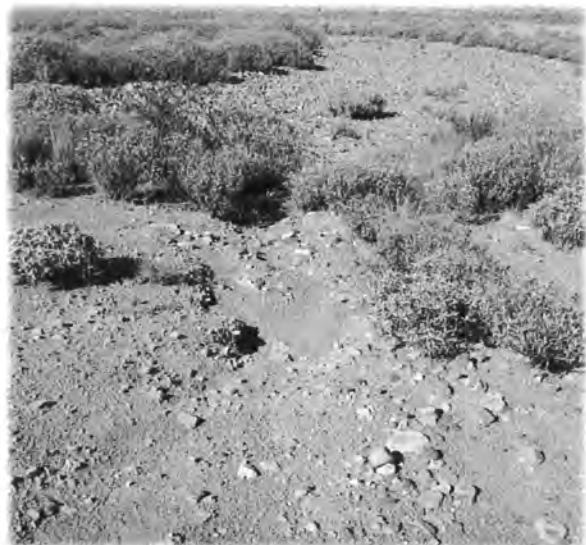
PHOTOGRAPH NO. 4

Significant erosion was observed on the west, north, and south slopes of the landfill cap. Erosion rills are developing along the top of the landfill cap adjacent to the spillway channels.

Erosion rills developing at the south (top) end of spillway. Viewed from the south.

RECOMMENDED CORRECTIVE ACTIONS: Repair erosion throughout landfill cap and reinstall erosion controls.

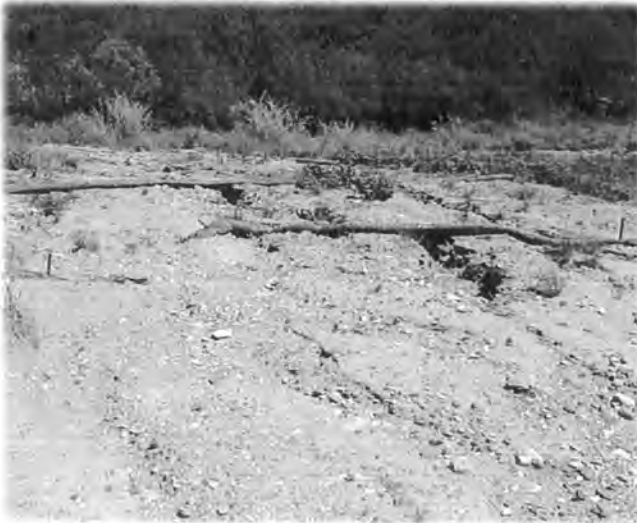
PHOTOGRAPH NO. 5
Erosion rills located on north end of west slope.
Viewed from the east.

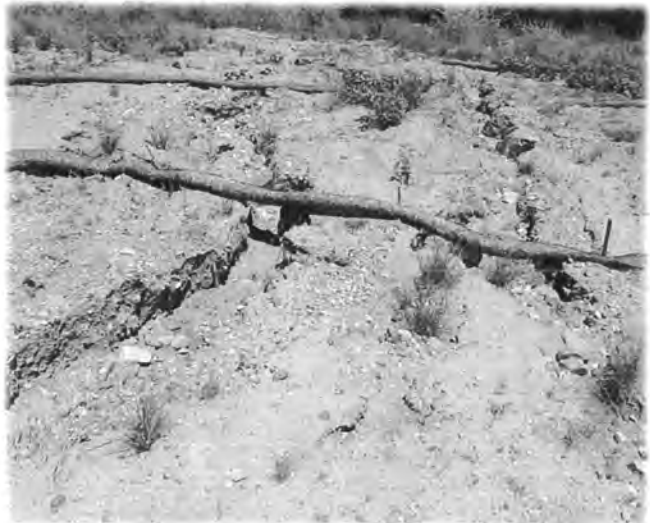
PHOTOGRAPH NO. 6
Erosion rills located on west slope. Viewed from the
north.

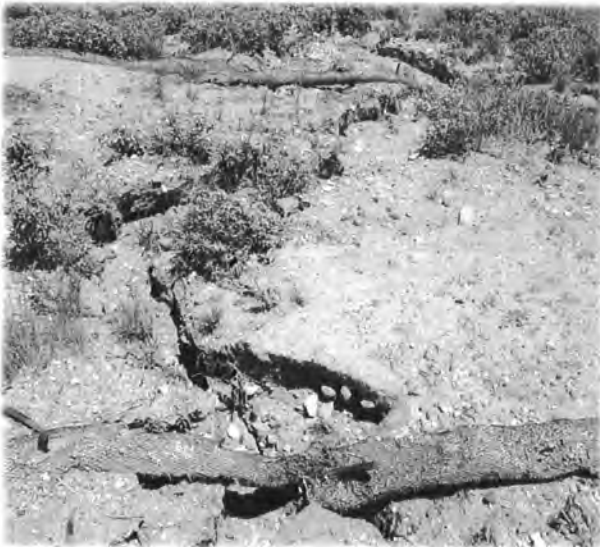
Most of the storm water waddles are undercut and no longer effective.

PHOTOGRAPH NO. 7
Erosion rills and undermined straw waddles
on north slope. Viewed from the south.

Recommended Corrective Actions: Repair rills that have developed beneath waddles and reinstall.

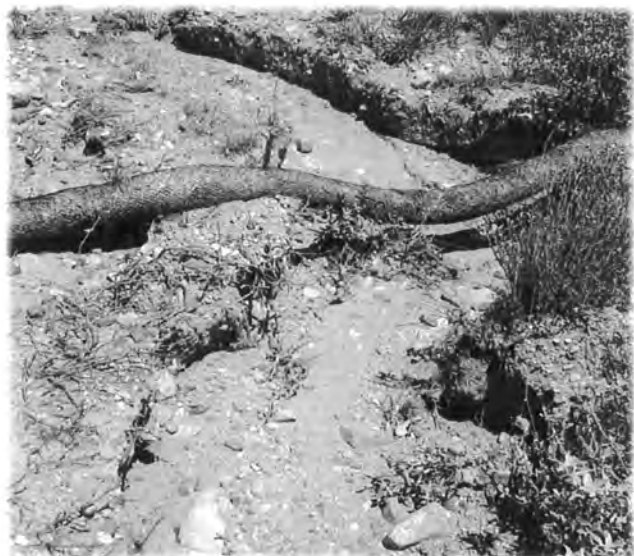
PHOTOGRAPH NO. 8
Erosion rills and undermined straw waddles
on north slope. Viewed from the north.

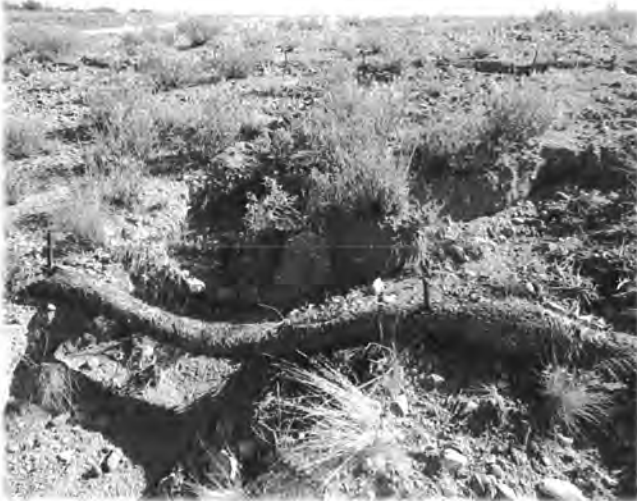
PHOTOGRAPH NO. 9
Erosion rills located on north slope. Viewed from the west.

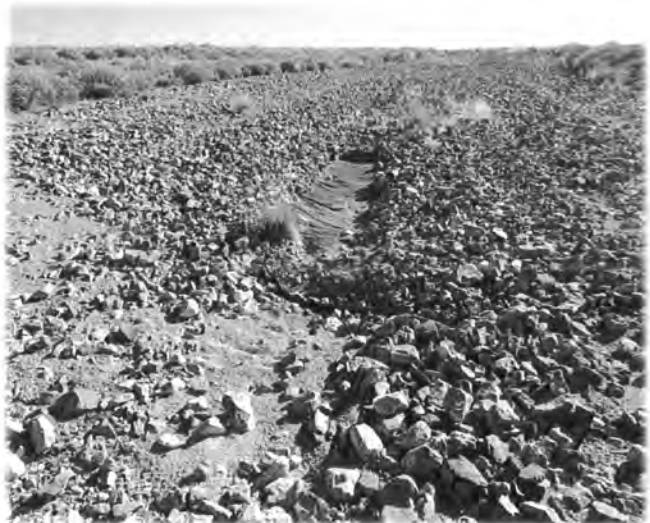
PHOTOGRAPH NO. 10
Exposed silt covered fabric located on north spillway. Viewed from the North.

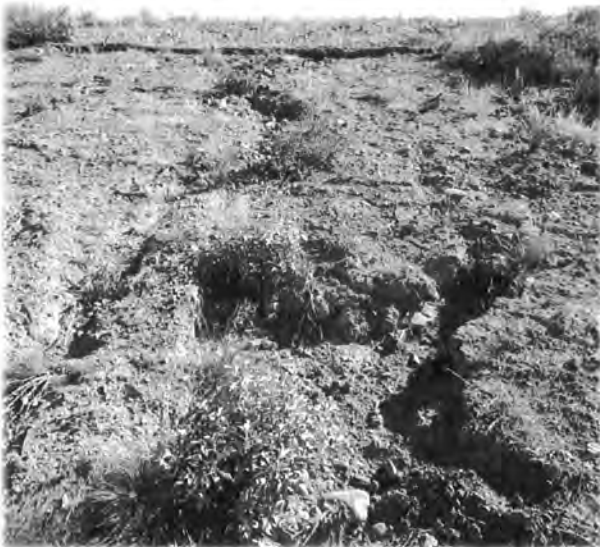
PHOTOGRAPH NO. 11
Erosion rills parallel to the west spillway. Viewed from the North.

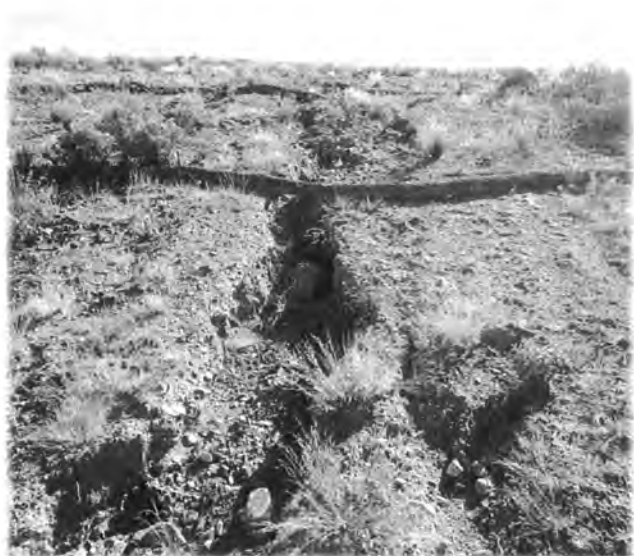
PHOTOGRAPH NO. 12
Erosion rills parallel to the west spillway. Viewed from the North.

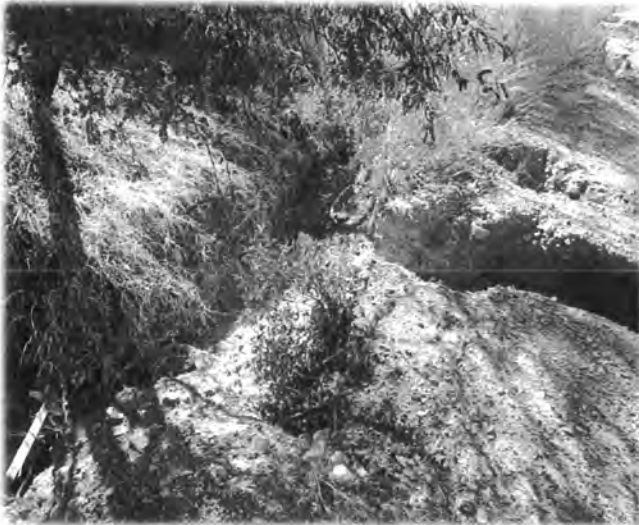
Significant erosion was observed along the southern inspection road.

PHOTOGRAPH NO. 13
Deep erosion rills located along the south inspection road. Viewed from the east.

Recommended Corrective Actions: Repair road, adjacent shoulder and reinstall erosion controls.

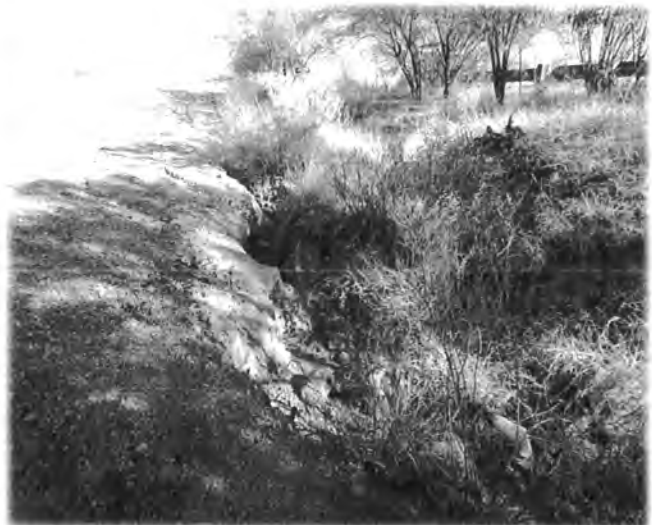
PHOTOGRAPH NO. 14
Deep erosion rills located along the south inspection road. Viewed from the west.

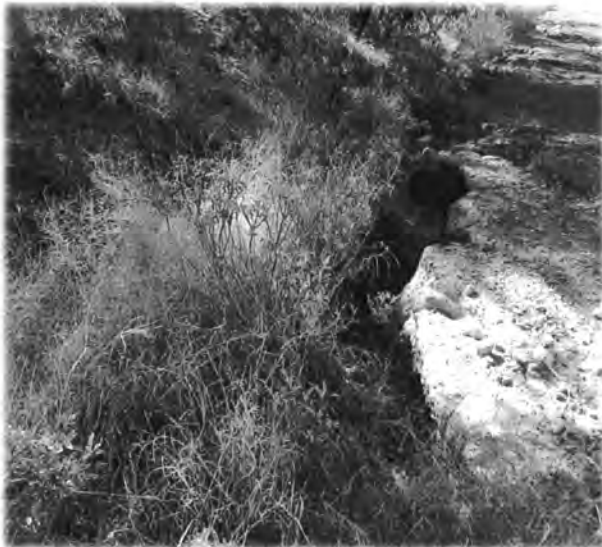
PHOTOGRAPH NO. 15
Deep erosion rills located along the south inspection road. Viewed from the north.

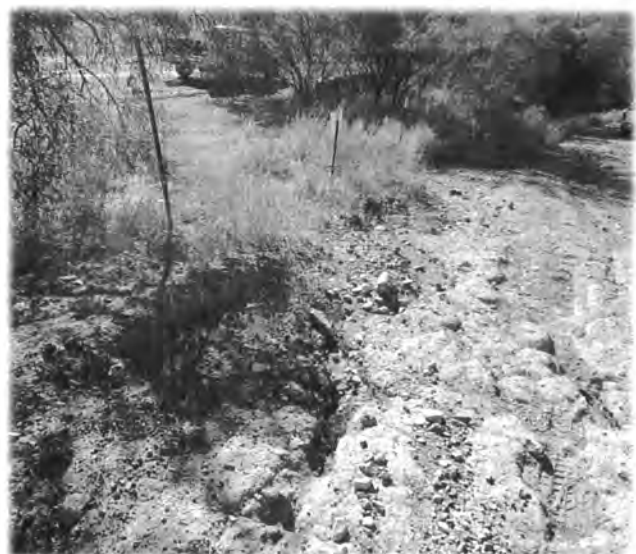
PHOTOGRAPH NO. 16
Deep erosion rills located along the south inspection road. Viewed from the east.

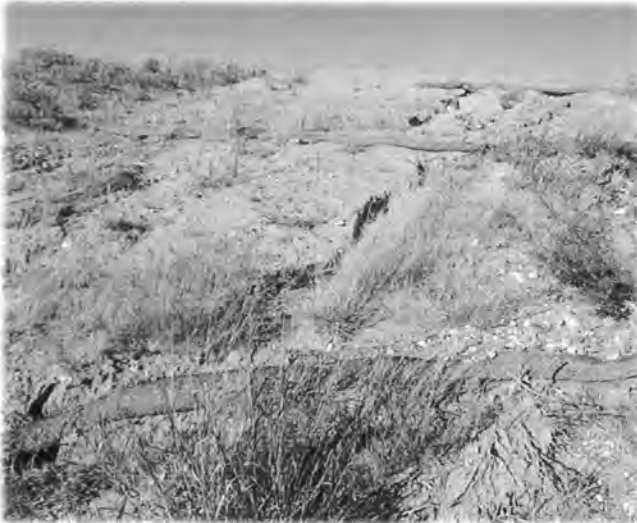
PHOTOGRAPH NO. 17

Deep erosion rills located along the south inspection road. Viewed from the south.

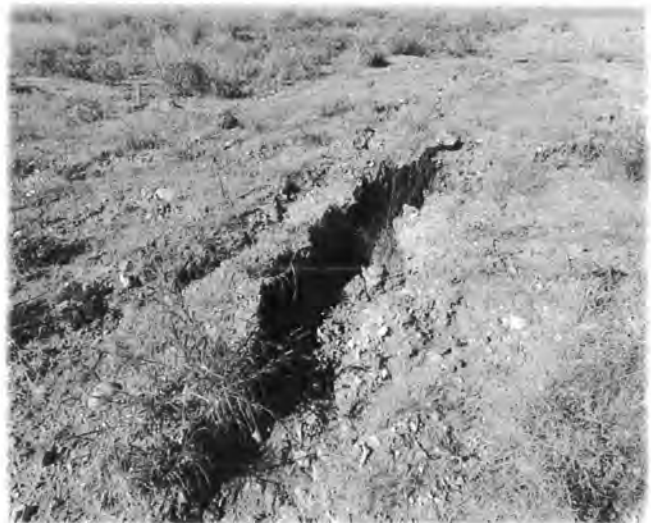
PHOTOGRAPH NO. 18

Deep erosion rills located along the south inspection road. Viewed from the south.

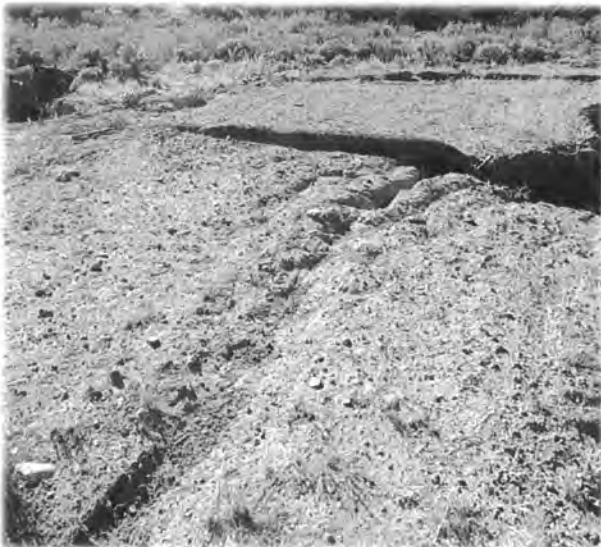
PHOTOGRAPH NO. 19

Deep erosion rills located on the west. Viewed from the south.

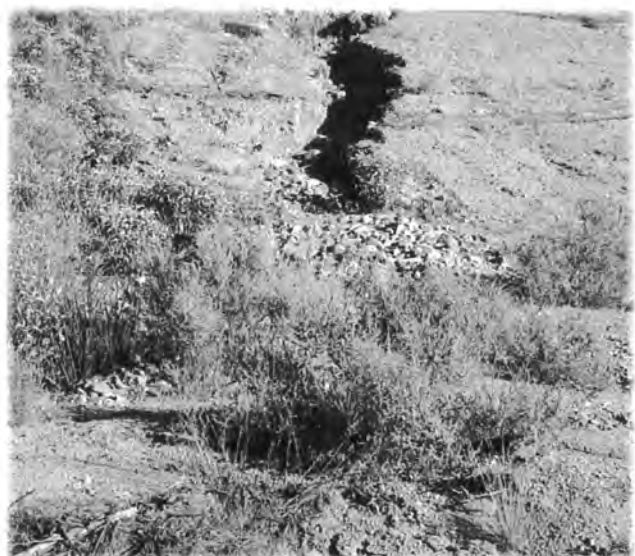
PHOTOGRAPH NO. 20

Deep erosion rills located on the west slope. Viewed from the west.

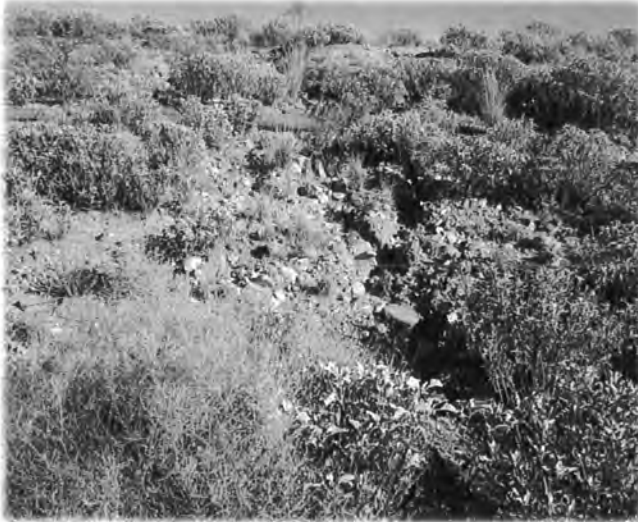
PHOTOGRAPH NO. 21
Deep erosion rills located along the on the south slope. Viewed from the south.

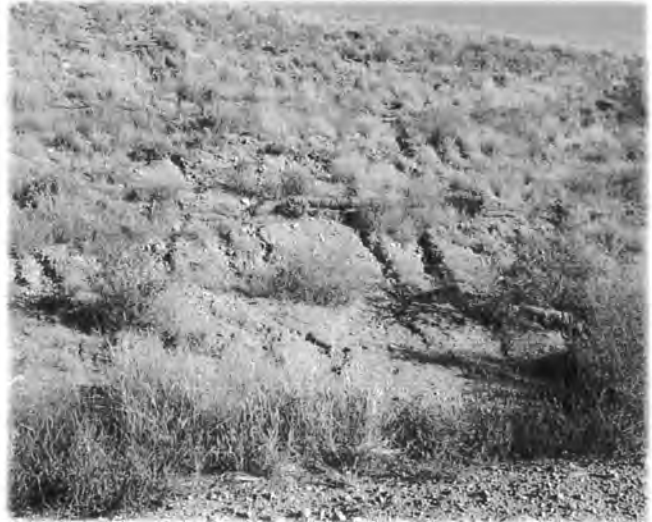
PHOTOGRAPH NO. 22
Deep erosion rills located along the on the south slope. Viewed from the south.

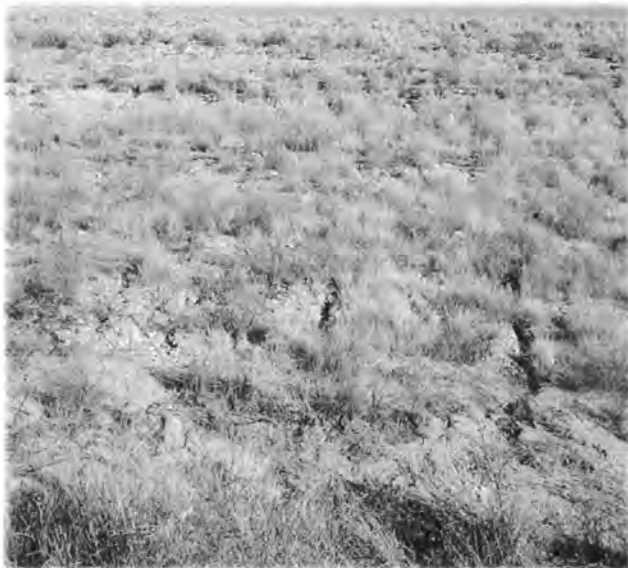
PHOTOGRAPH NO. 23
Deep erosion rills located along the on the west. Viewed from the south.

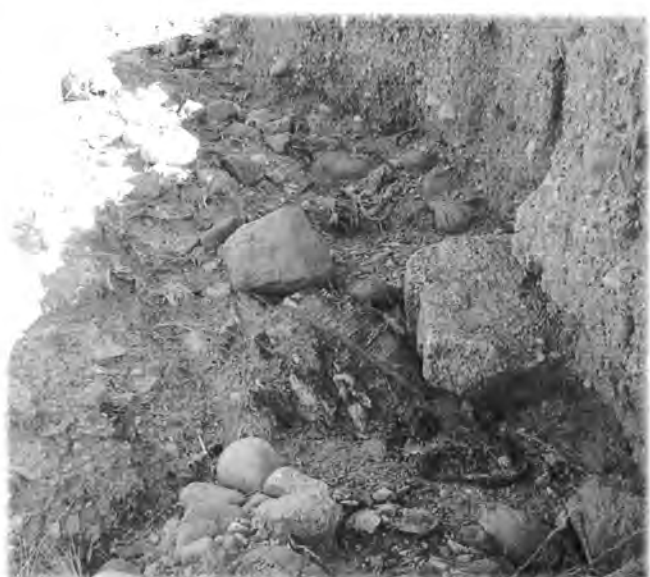
PHOTOGRAPH NO. 24
Deep erosion rills located along the on the west slope. Viewed from the west.
