**Environmental  
Services**

**CITY OF TUCSON  
COMPREHENSIVE LANDFILL INVESTIGATION  
FINAL REPORT  
MARCH 2011**

**City of Tucson  
Environmental Services  
4004 S. Park Avenue  
Tucson, AZ 85714**

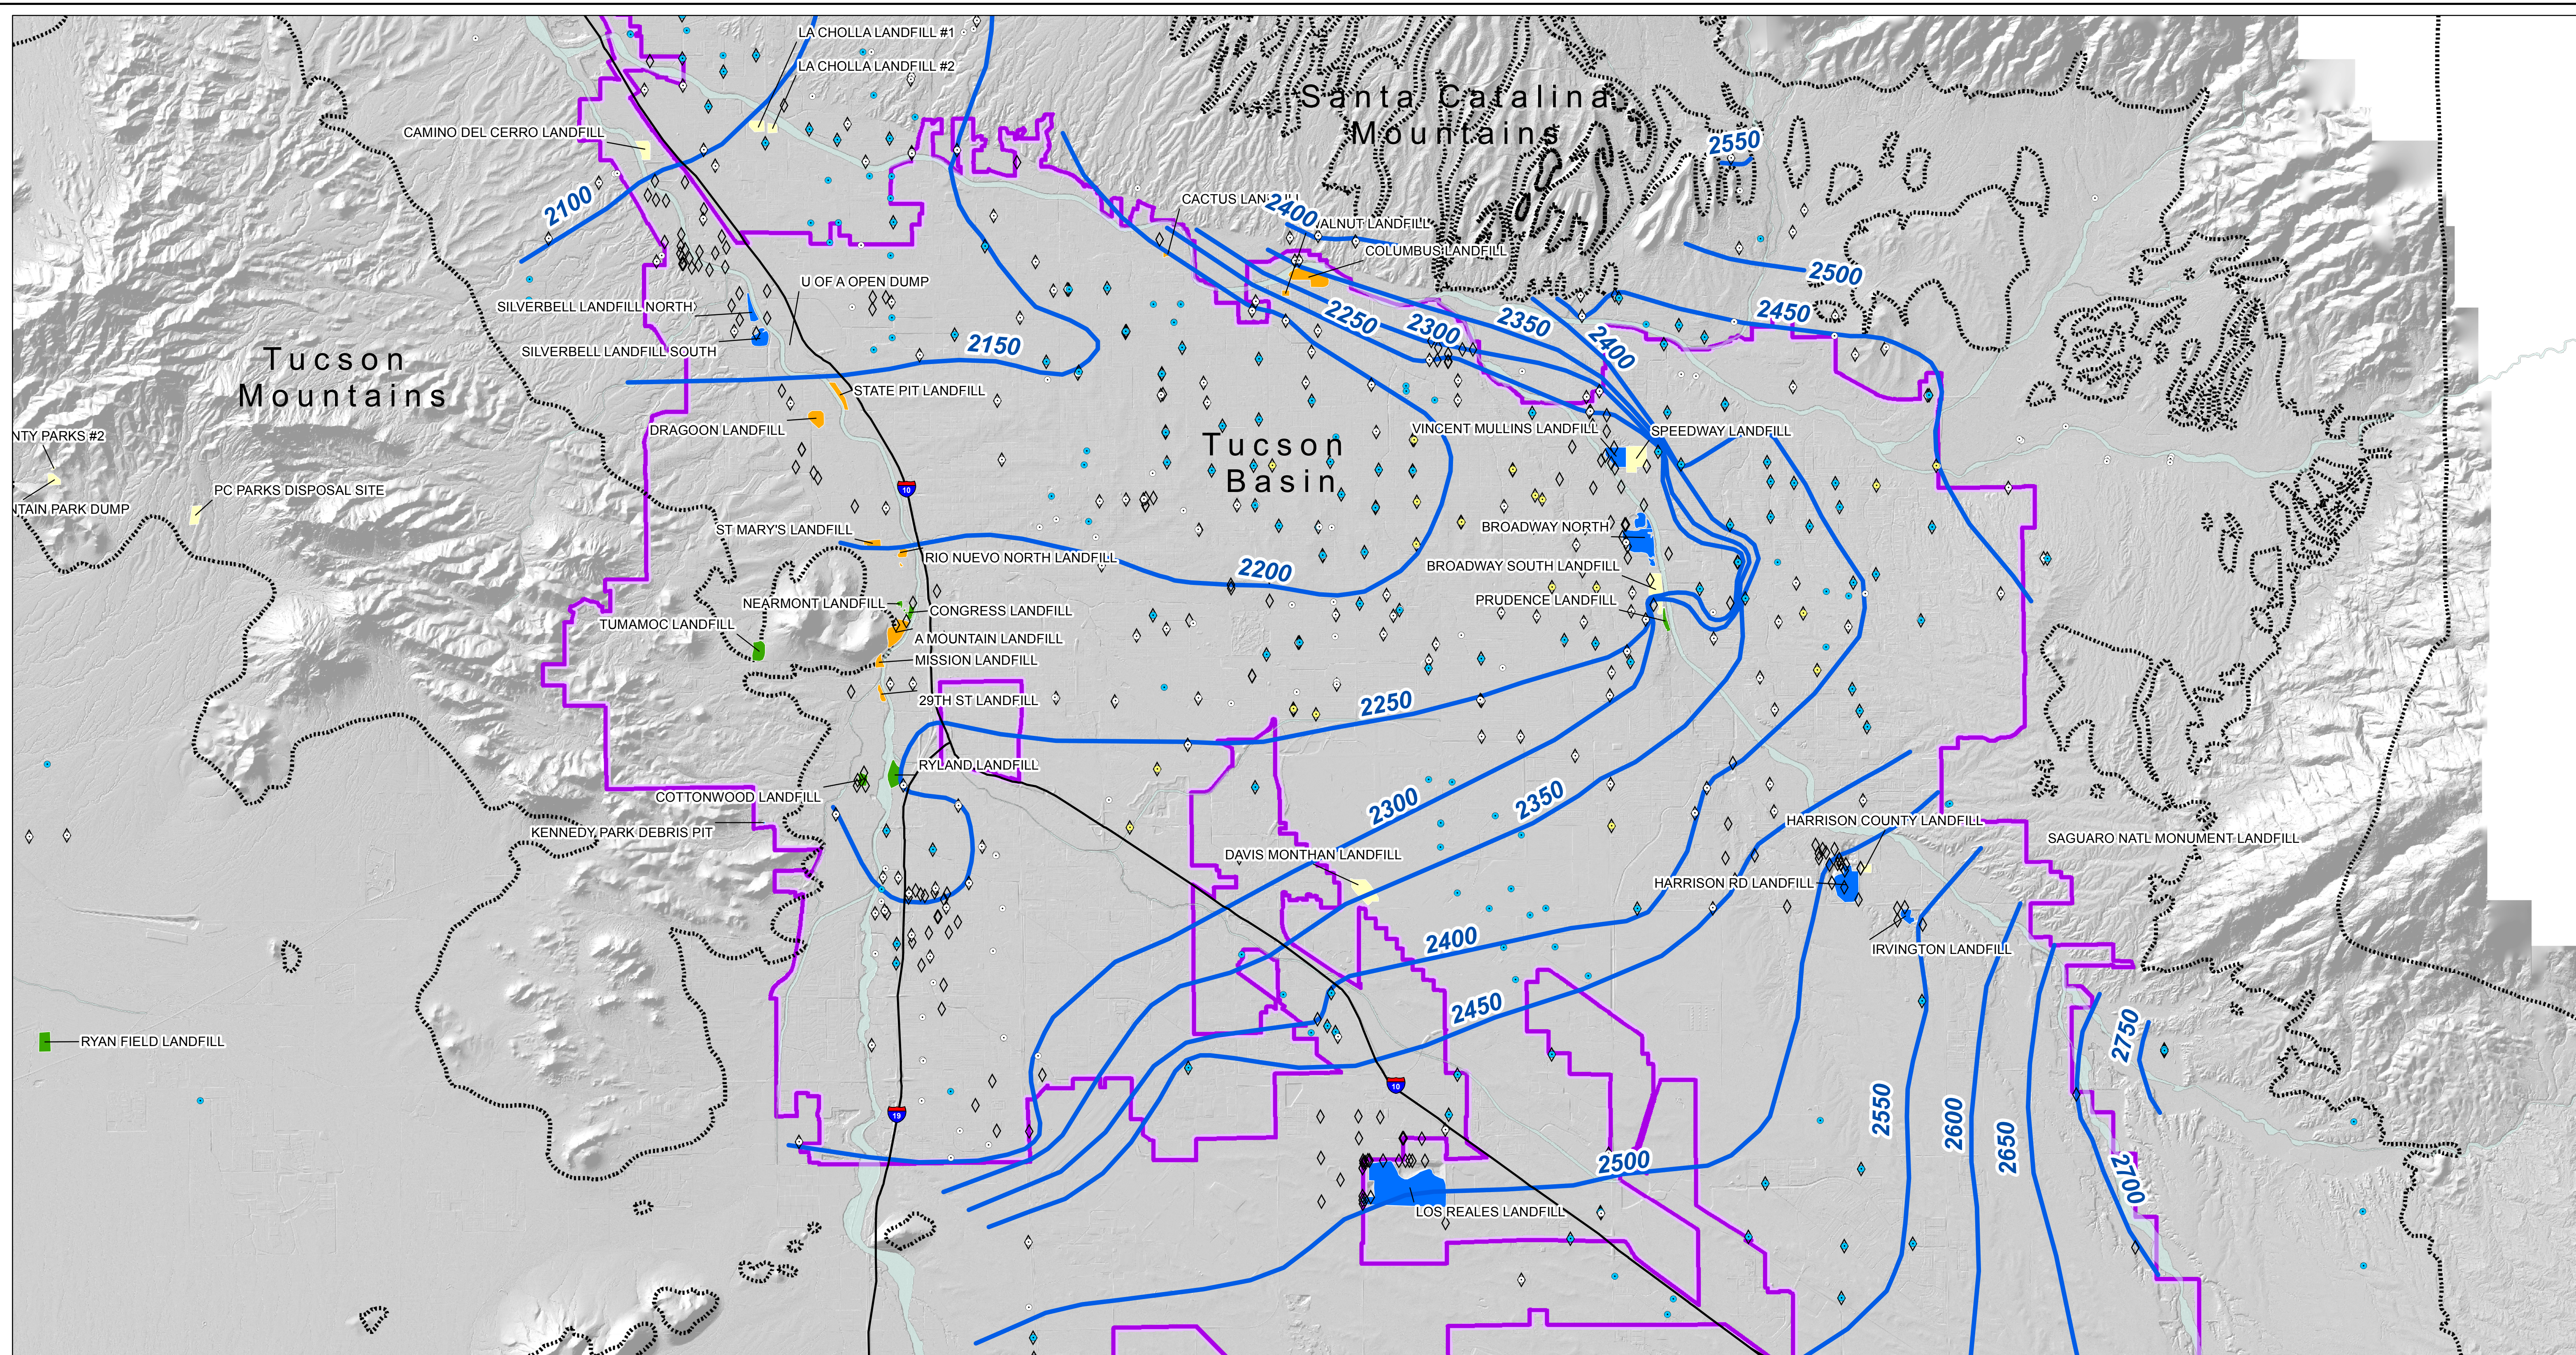
**Figure 2**  
**Landfill Locations and**  
**2007 - 2008 Regional**  
**Water Level Contour Map**

Tucson Water staff collect non-pumping regional groundwater levels at City-owned wells between November and February of each year. COT-ES, Marana, and Metropolitan Domestic Water Improvement District (DWID) also provide water level data to Tucson Water during that same time period. Tucson Water staff prepare a regional groundwater map for each annual collection period, however it may take several years between data collection and publishing of the map. Therefore, COT-ES used the data collected in 2007 and 2008 from 730 non-pumping wells to contour a groundwater elevation map for use with this report. The groundwater elevation contour map is shown in Figure 2.

The Tucson basin is a valley bordered by the Tucson Mountains to the west, Santa Catalina Mountains to the north, and the Rincon Mountains to the east. Groundwater flow in the basin is generally to the northwest except near the Santa Catalina Mountains, where flow is to the southwest.

The contours provided in Figure 2 are incorporated into Figures 4 and 5 of this report so groundwater flow direction can be seen in selected individual project areas.

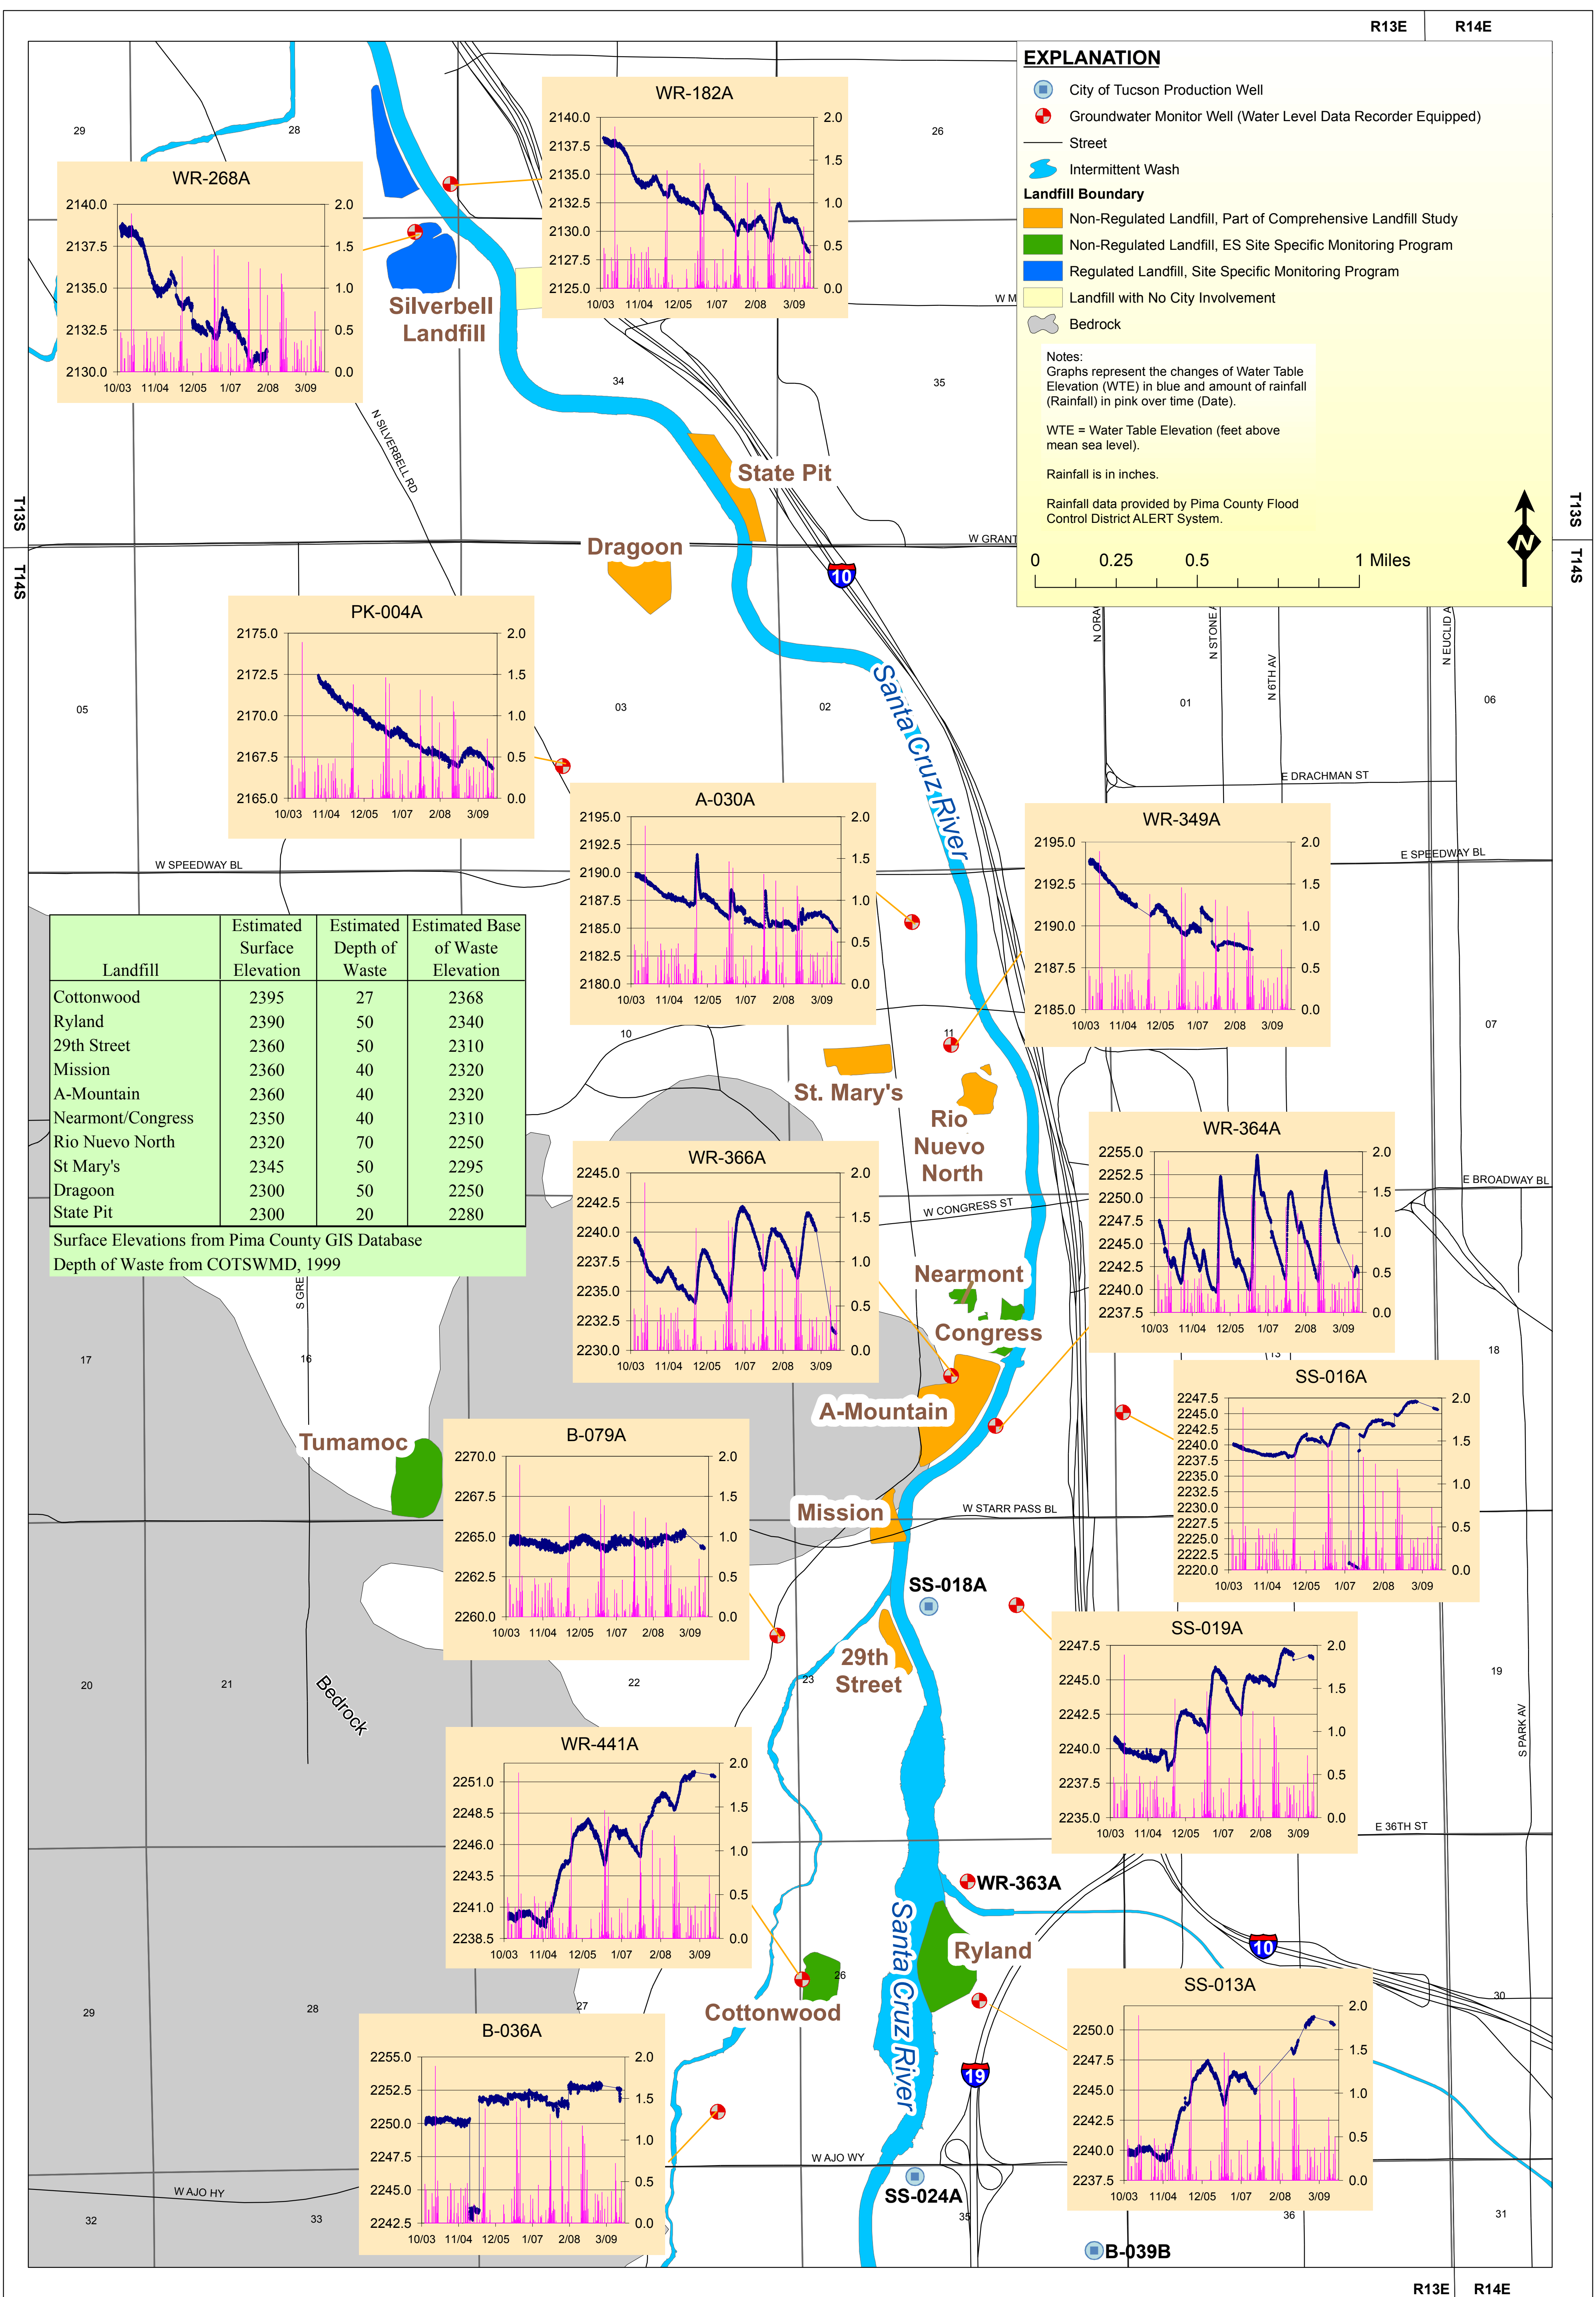
**FIGURE 3**  
**SANTA CRUZ WATER LEVEL STUDY, TUCSON, AZ**  
**HYDROGRAPHS SHOWING WATER TABLE ELEVATION**  
**OCTOBER 2003 THRU NOVEMBER 2009**

There are thirteen closed landfills within the approximately 7 mile segment of the Santa Cruz River bounded by Mission Road/Silverbell Road to the west, the Silverbell Golf Course to the north, Stone/6<sup>th</sup> Avenue to the east and West Ajo Way to the south. The landfills are, from north to south: Silverbell, UofA Open Dump, State Pit, Dragoon, St. Mary's, Rio Nuevo North, Nearmont, Congress, A-Mountain, Mission, 29<sup>th</sup> Street, Cottonwood, and Ryland (Figure 3). Dedicated transducers and automatic data loggers were installed in twelve groundwater wells in 2003 (Figure 3). Data were recorded every 12 hours. Three times a year, COT ES staff downloaded the transducer data in the field and then appended it to historical data in the office. Hydrographs are produced for each well and are included on Figure 3. The hydrographs also include rainfall data.

Variables that can influence the hydrograph trends seen on Figure 3 include distance from the Santa Cruz River, lithology, well construction, and precipitation. With the exception of B-079A, most monitoring wells show noticeable spikes in water levels in response to summertime monsoon rains. At B-079A, the water level in the well is approximately 20 feet higher than nearby regional groundwater wells, and the water levels in the well do not respond to

In general, water levels in wells north of A-Mountain have been decreasing an average of 1.2 feet per year (ft/yr). The wells north of A-Mountain with the greatest average decreases are WR-349A at -1.20 ft/yr, and WR-182A at -1.65 ft/yr. Water levels in wells south of A-Mountain have been increasing an average of 1.5 feet per year. The wells south of A-Mountain with the greatest average increases are WR-441A and SS-013A, which have each increased an average of +2.34 ft/yr.

Monitoring well WR-364A, located 80 ft from the Santa Cruz River to the east of A-Mountain Landfill, had the most immediate and significant response to precipitation with an approximate 14 foot rise in September 2006. The groundwater elevation at this well was 2254.65 feet above mean sea level (ft amsl) in September 2006. This maximum groundwater elevation is still approximately 105 ft below ground surface, and about 60 feet below the estimated maximum bottom depth of refuse in the A-Mountain Landfill.

Among the wells south of A-Mountain which are experiencing an overall increasing trend in water levels, monitoring well WR-441A, located next to Cottonwood Landfill, has had the most significant increase and has the highest groundwater elevation (2251.86 ft amsl) for this area. Using a linear trend line for the groundwater elevation data collected from WR-441A since 2005, the increasing slope is +0.0049 ft/day or +1.79 ft/yr. If the current trend seen in WR-441A continues, it will take approximately 52 years for the water table to reach bottom of estimated elevation of refuse at the Cottonwood Landfill at 2346 ft amsl. Tucson Water Staff have also noticed this increasing groundwater elevation trend south of A-Mountain, particularly near the Tucson International Airport and near Pima Mine Road. Wally Wilson with Tucson Water attribute this change to increased use of Central Arizona Project (CAP) water by the Tohono O'Odham Nation and the two operating mines in the same vicinity, and their corresponding decreased use of groundwater (personal communication, January 28, 2011).

Figure 3 contains a table listing the estimated base of waste elevation for each landfill. Water level elevations in wells measured for the study are not high enough to be in contact with the base of waste. Water levels along the Santa Cruz River appear to respond mainly to precipitation events. In evaluating sporadic groundwater increases and potential increasing long-term trends, it appears that regional groundwater is not likely to come in contact with waste in the landfills. Therefore, the Santa Cruz Water Level Study will be discontinued, and most of the transducers and dataloggers will be removed and used at other sites as needed.

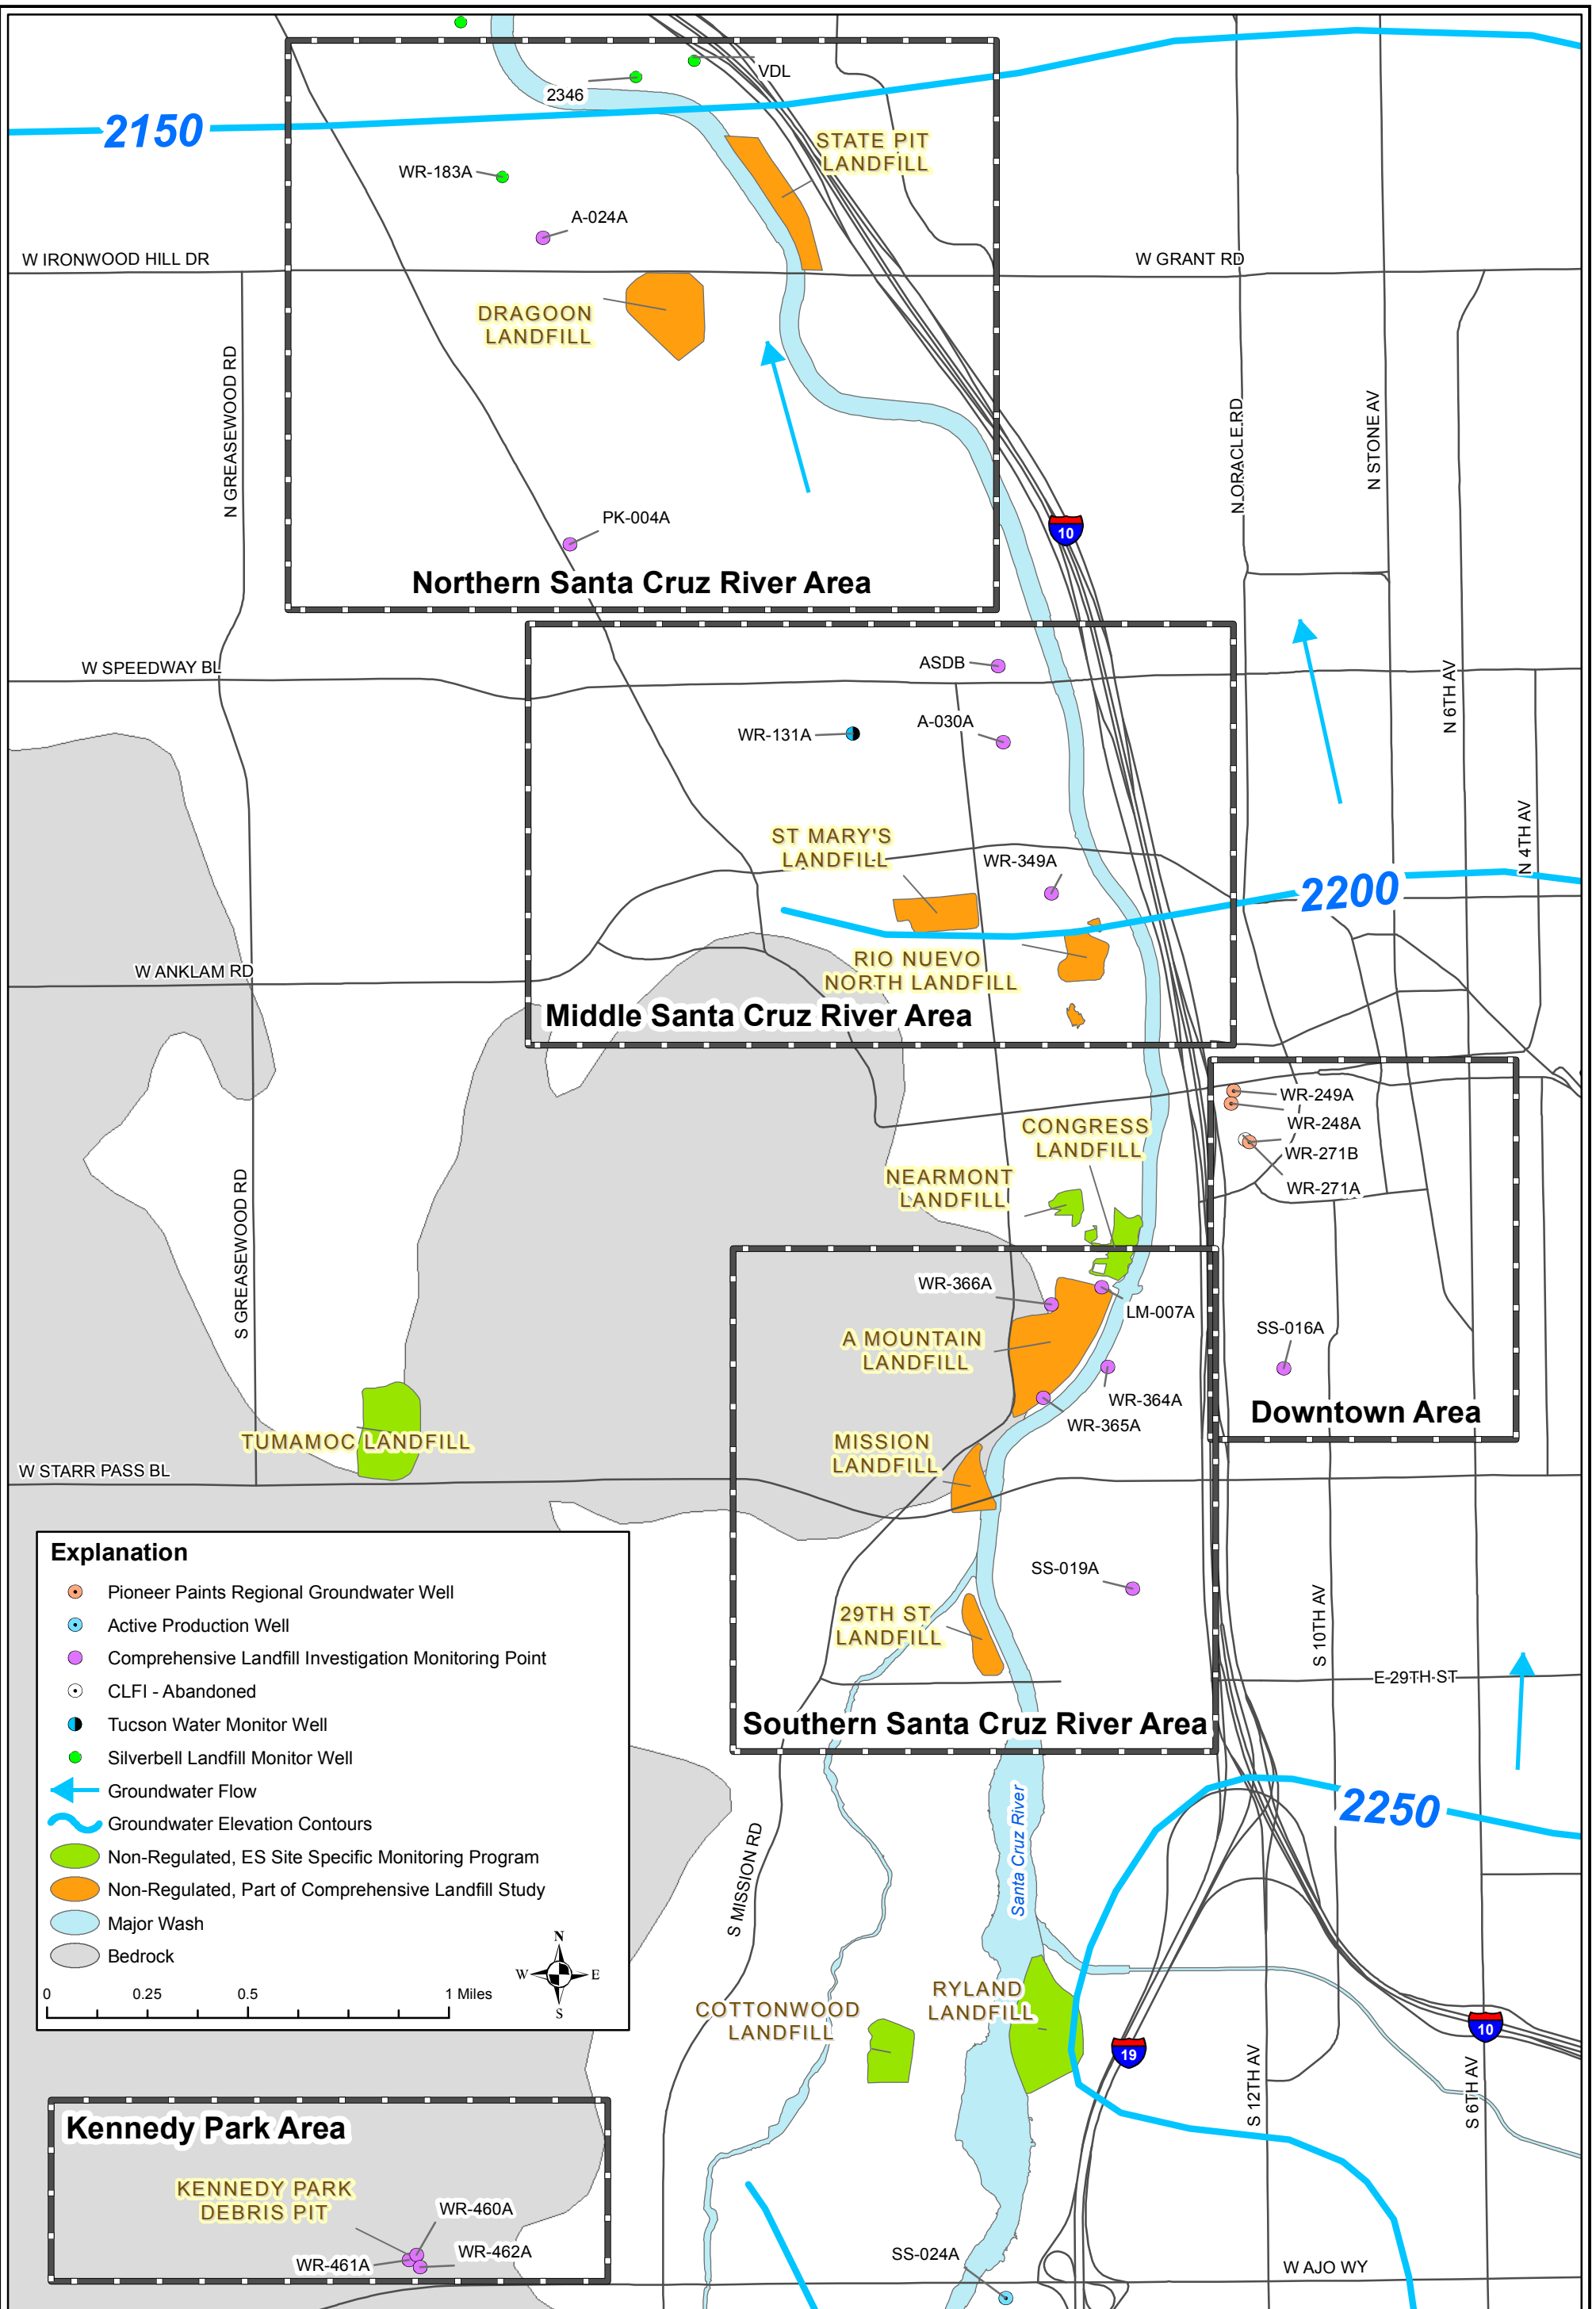
Figure 4  
 Santa Cruz River Corridor Vicinity Map  
 Comprehensive Landfill Investigation

The site was originally a rock quarry located near Ajo and Mission Roads at the current Kennedy Park Area (see Figure 4 for the general location of the site, and Attachment 1 for a site specific map). The site is owned and maintained by the City of Tucson. The City of Tucson Parks and Recreation used the pit from the mid to late 1970's to early 1980's for the disposal of excess soil from various sources, and construction debris including concrete, wood and steel. To their knowledge, no municipal waste was disposed (Wittwer, 1994). The debris pit appears to be exempted from the definition of a municipal solid waste facility as it mainly consists of landscaping rubble that was used to reclaim the land (ARS § 49-701.01 (B) 15). Therefore, this site does not fall under the state definition of a landfill. The property is currently operated by the City of Tucson Parks and Recreation as the Kennedy Park Fiesta Plaza. Below is a brief

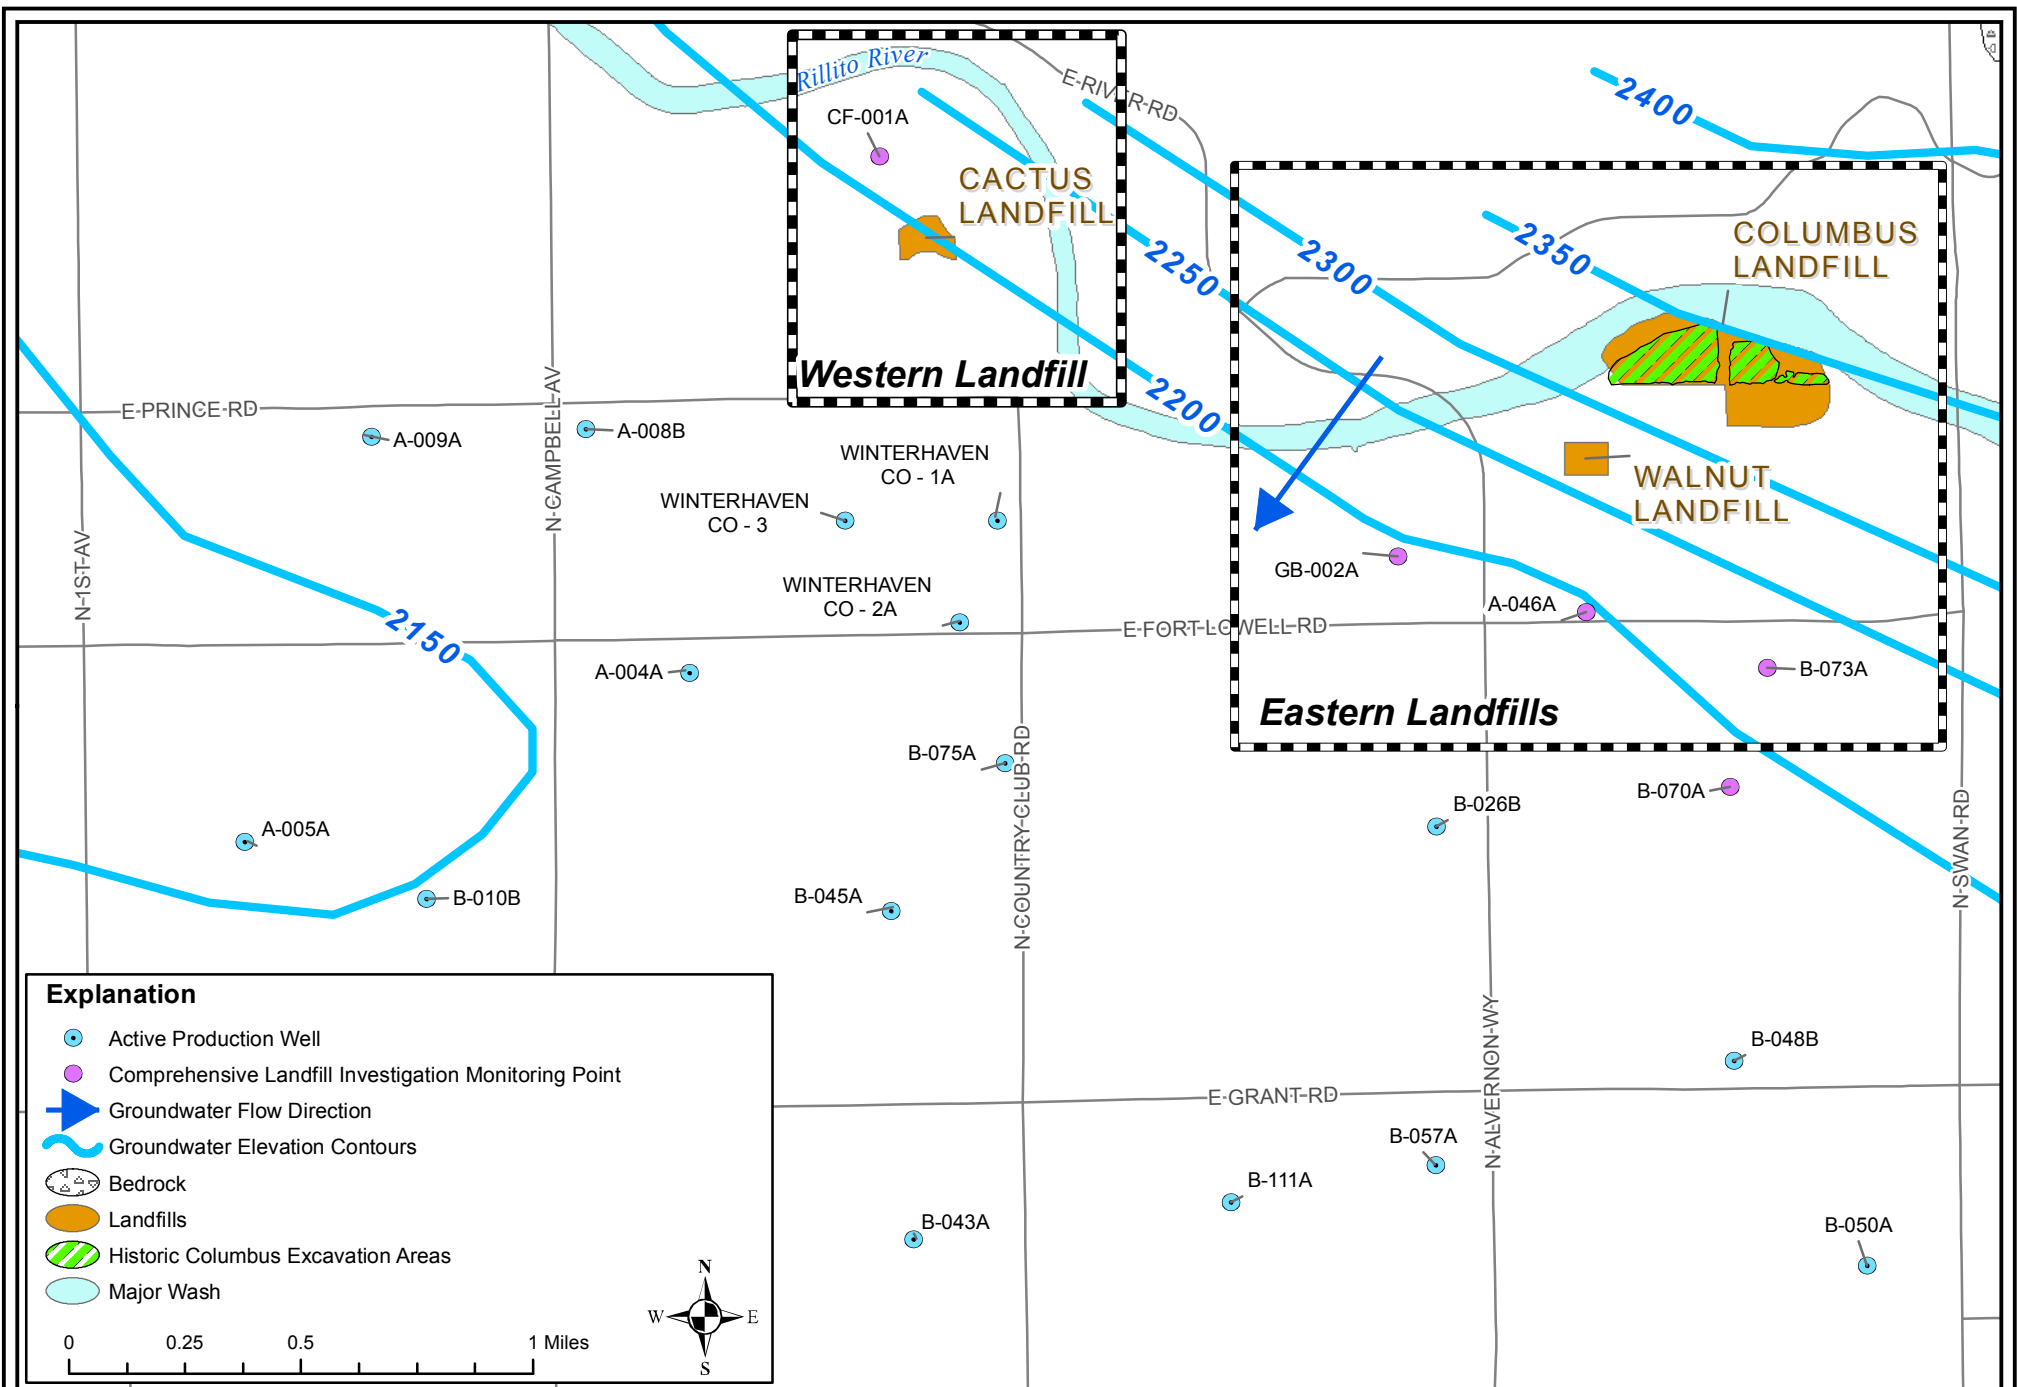
COT-ES. Borrow pits were observed in historical photographs from 1953 to 1974 and indicated a combined excavated area of 21 acres. The 21 acre boundary provided in the Aplomado 2002 report can also be seen in Figure 5. However, the Aplomado 2002 report does not review the historic borrow pits in the creek bed and also on the northern side of the Rillito River as discussed in PAG, 2000. There is no clear evidence showing that landfill activity extended beyond the southern bank of Rillito Creek (PAG, 2000).
