**IRVINGTON LANDFILL, TUCSON, ARIZONA**  
**2019 ANNUAL ENVIRONMENTAL REPORT**  
**AQUIFER PROTECTION PERMIT NO. 50044800.00**

January 2, 2020

City of Tucson  
Environmental & General Services Department  
P.O. Box 27210  
Tucson, Arizona 85726-7210

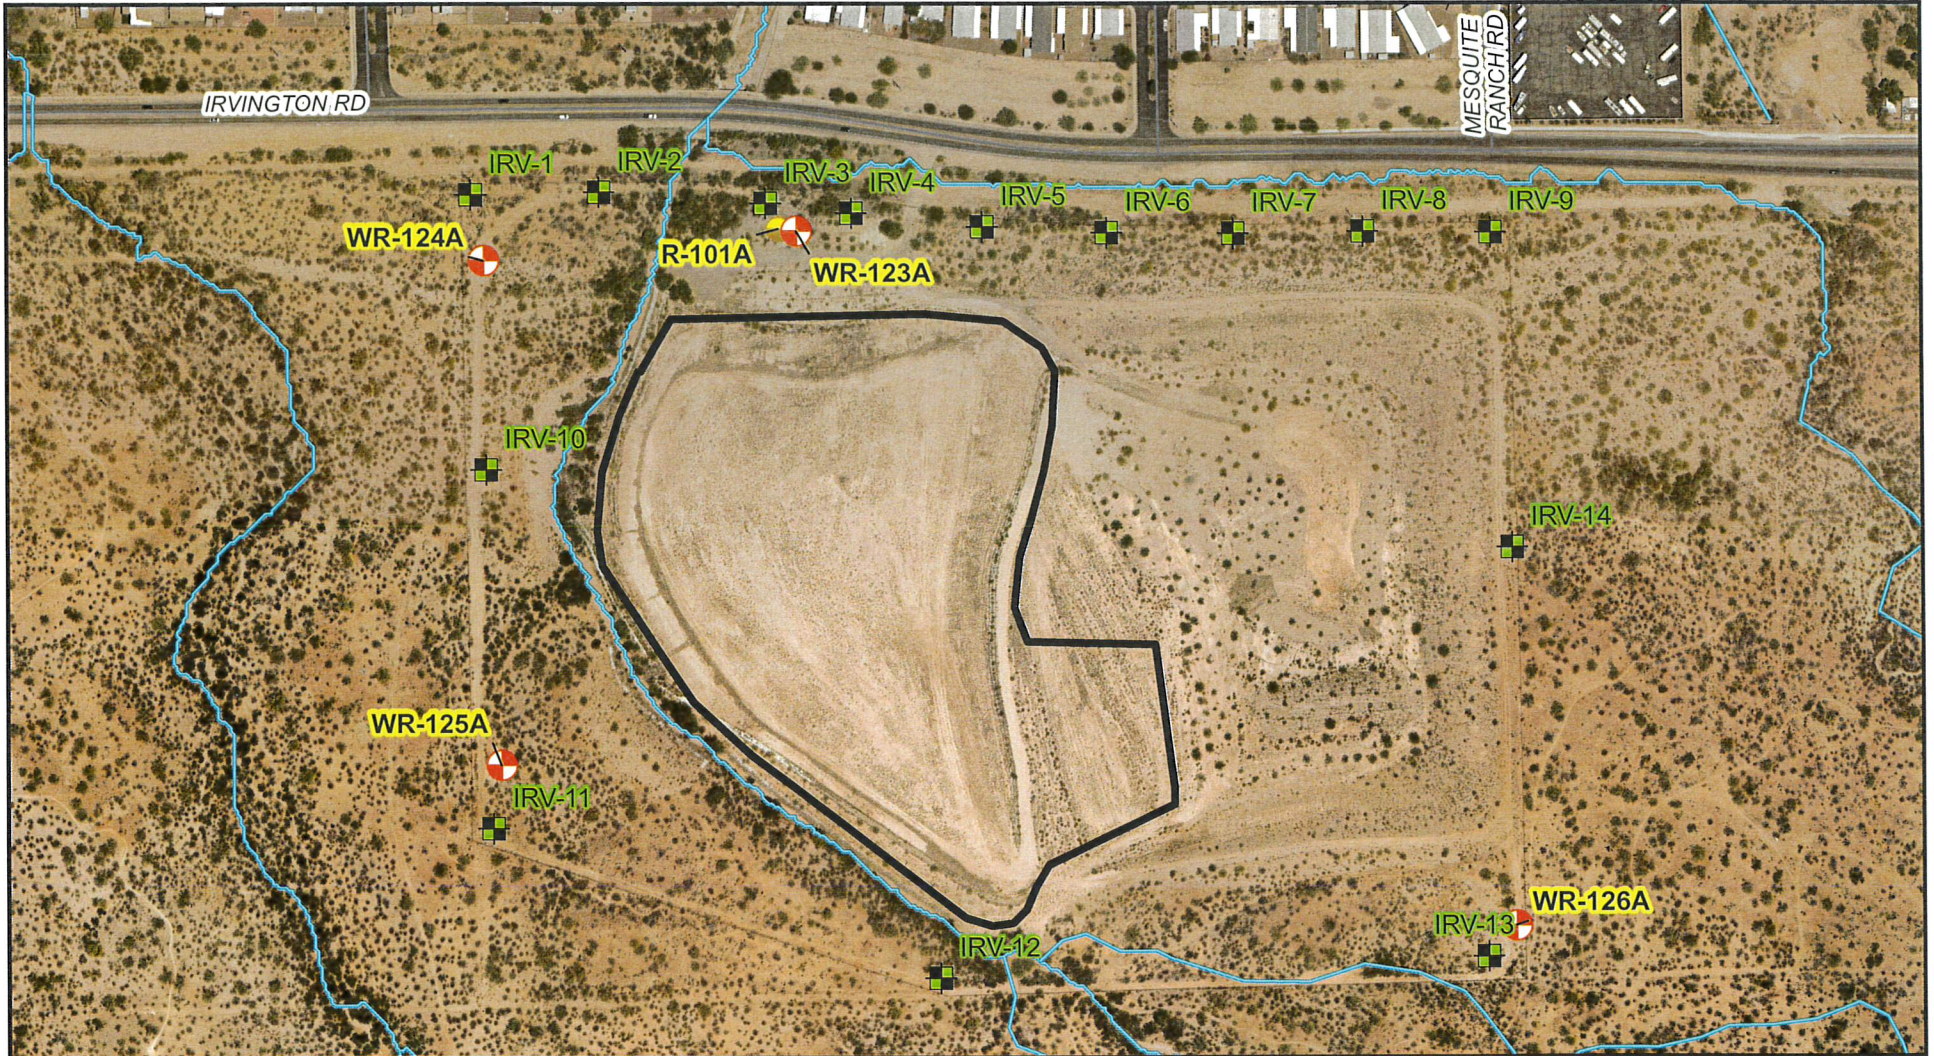
Figure 2  
Site Map Irvington Landfill  
Tucson, Az

There are 14 methane gas monitoring probes, designated as probes IRV-1 through IRV-14, located around the perimeter of the Irvington Landfill. Each probe is constructed to allow for a soil vapor (methane gas) sample to be collected at depths of 10 feet and 25 feet below ground surface. The gas monitoring probe locations are shown on **Figure 2**.

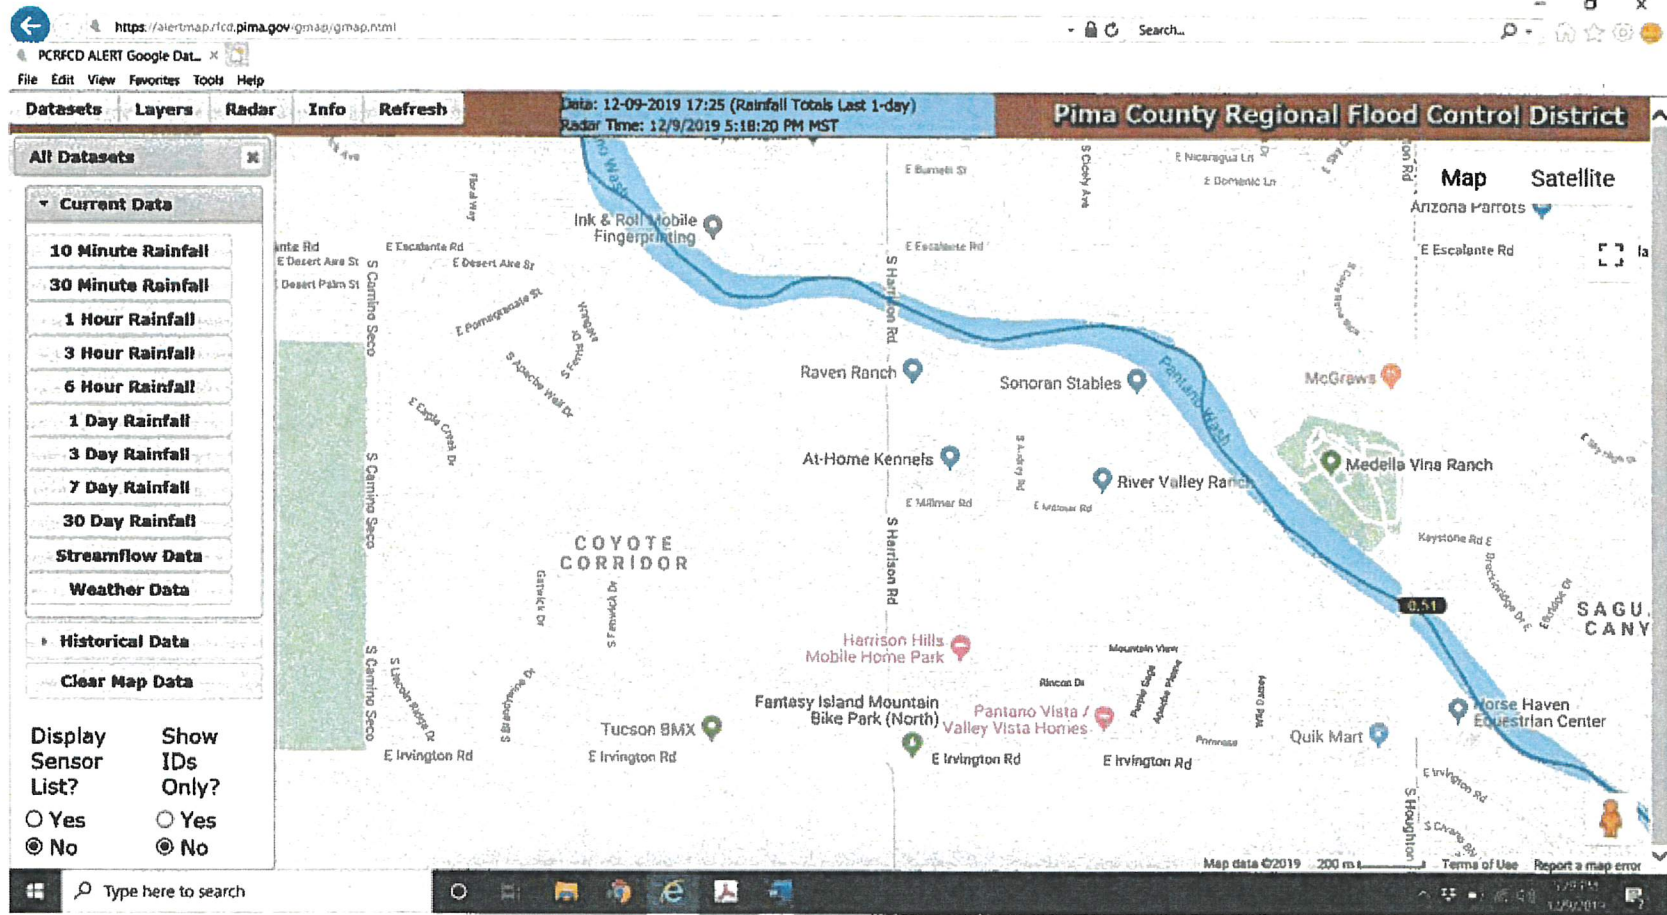
# Rain Event 12-8-19 Harrison and Irvington

INSPECTION ITEM	DISCREPANCY	CORRECTIVE ACTION
<b>Perimeter Security Fence and Gate</b> (holes, structure issues)	No discrepancy	
<b>Inspection Roads</b> (washouts, obstructions, potholes)	South perimeter road impassible (erosion and wash). Increasing rills on west perimeter road	Re-evaluate after conclusion of Monsoon season.
<b>Storm Water Controls</b> (berms, let downs, spillways)	No discrepancy	
<b>Storm Water Retention Basins</b> (washouts, excessive silt in, holding water)	No discrepancy	
<b>Landfill Earthen Cap</b> (washouts, trash showing, debris and trash)	No discrepancy	
<b>Landfill Gas Extraction System Wellfield</b> (piping, wells, vaults, washouts)	None	
<b>Landfill Gas Extraction System Compound</b> (fencing, blower equipment, flare, carbon canisters)	None	
<b>Landfill Gas Monitoring Wells</b> (including bollards, vaults, locks)	No discrepancy	
<b>Groundwater Monitoring Wells</b> (including bollards, vaults, locks)	No discrepancy
